REPUBLIC OF TURKEY
MINISTRY OF INTERIOR
**DISASTER AND EMERGENCY
MANAGEMENT AUTHORITY**

**THE $M_w=6.6$ SAMOS ISLAND
(OFFSHORE- İZMİR) EARTHQUAKE
OF 30 OCTOBER 2020**

**EARTHQUAKE DEPARTMENT
ANKARA
DECEMBER 2020**

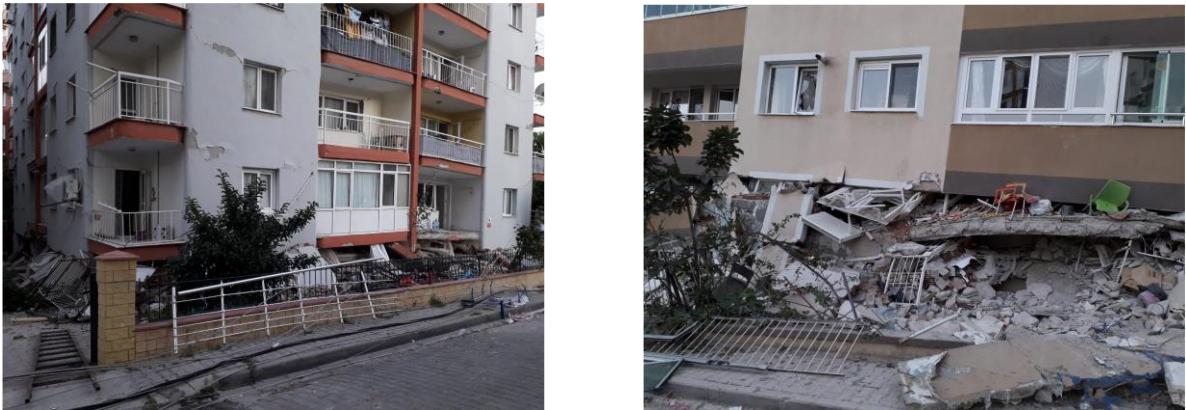
Figure 5.1 Heavily damaged buildings as a result of soft story collapse

- b) Soft story effect was observed in most of the heavily damaged buildings. Soft story mechanism was formed due to infill walls that do not exist in the ground story but exist in the upper stories (Figure 5.1).

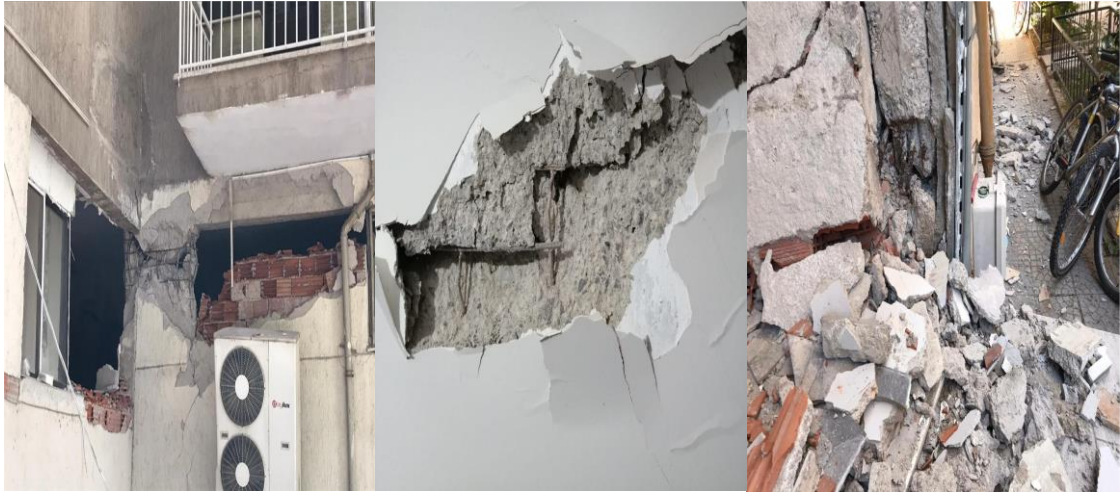
- c) The concrete quality of damaged buildings was generally observed to be poor.
- d) In damaged buildings, improper detailing of reinforcement was generally observed (Figure 5.2).

Figure 5.2 Damage due to improper detailing of reinforcement.

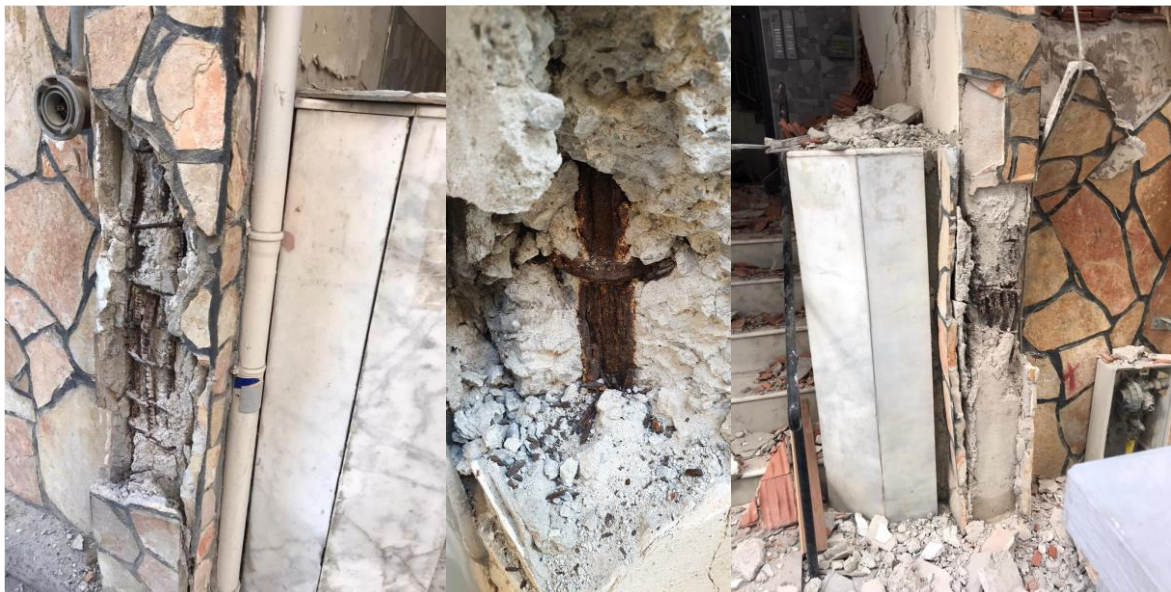
- f) In most of the heavily damaged buildings, excessive corrosion especially at lower stories was observed (Figure 5.3).
- g) There were many buildings whose infill walls were heavily damaged although their structural systems were not damaged (Figure 5.4).

Figure 5.3 Corroded reinforcements and inadequate confinement.

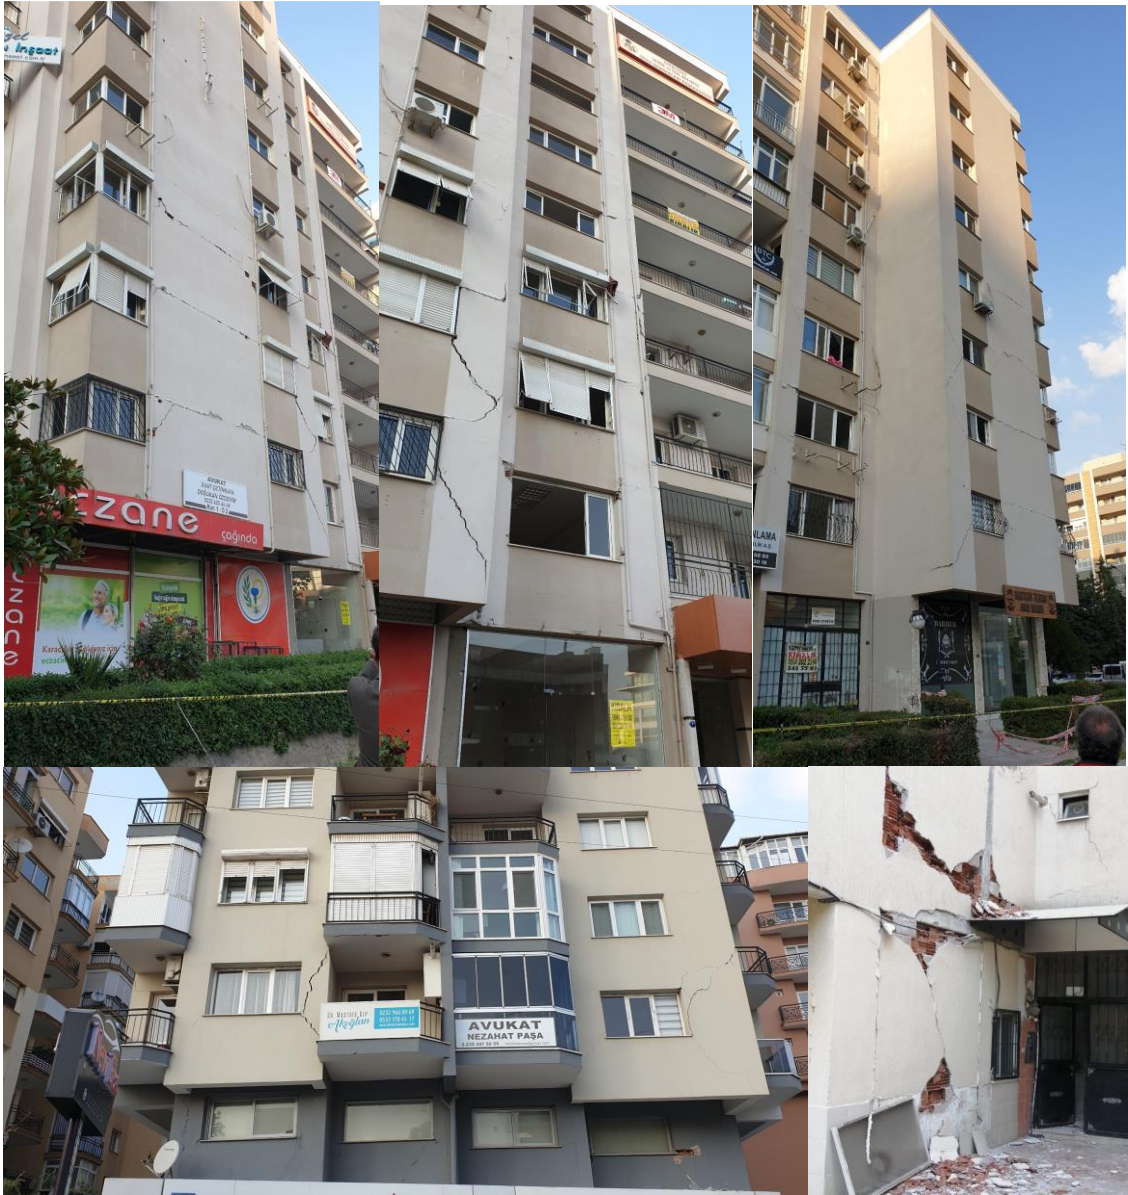
Figure 5.4 Infill wall damages.

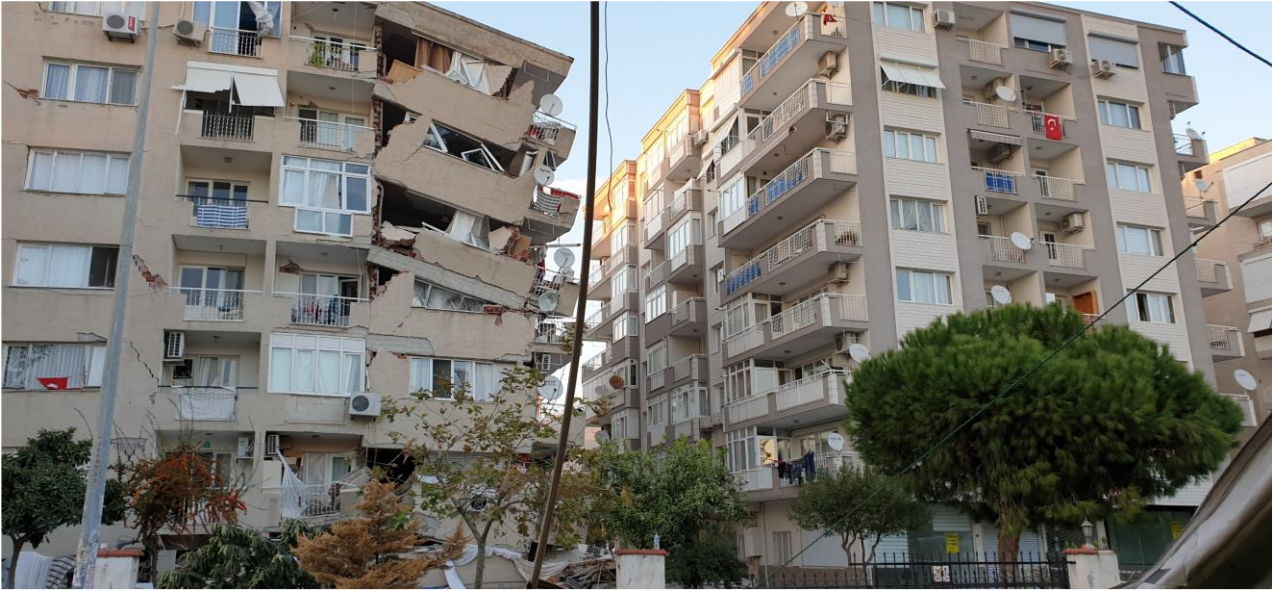
- h) It is understood that frame irregularity and heavy overhangs observed in the buildings are another important factor causing damage (Figure 5.5).
- i) It was observed that in the same building complex, some of the buildings collapsed while others with the same architectural and structural configuration survived with less damage. The fact that the collapsed and surviving buildings were constructed by different people has shown that the quality of material and workmanship is one of the important parameters affecting the performance of the building.

Figure 5.5 Damage observed in the buildings with heavy overhangs.
