Newsletter of **Environmental, Disaster, and Crises Management Strategies**

Issue No.15 | November 2019

The November 26, 2019 Mw 6.4 Durrës (Albania) earthquake

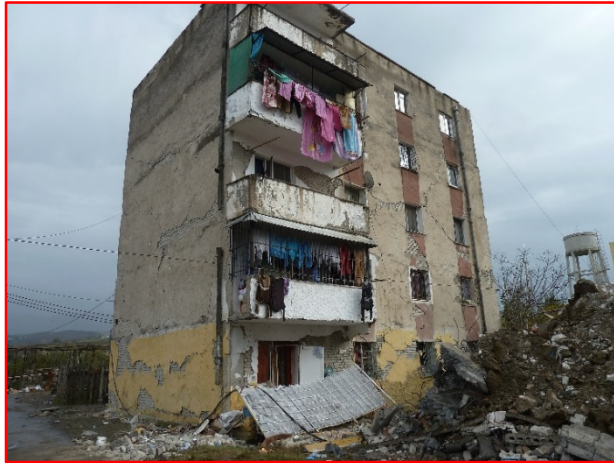
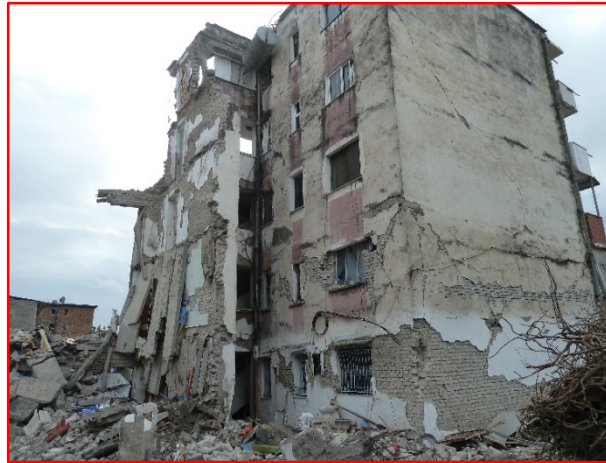
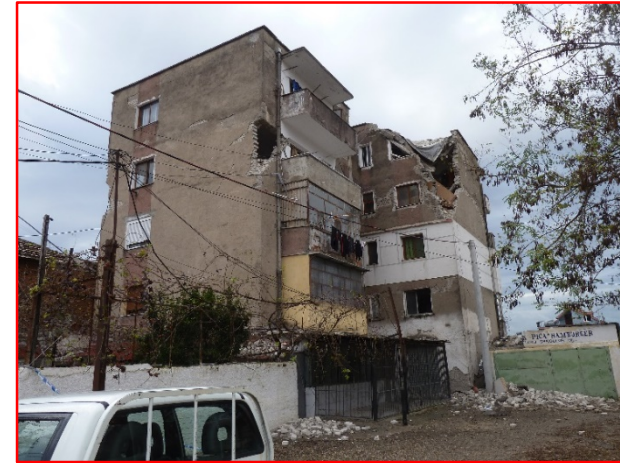
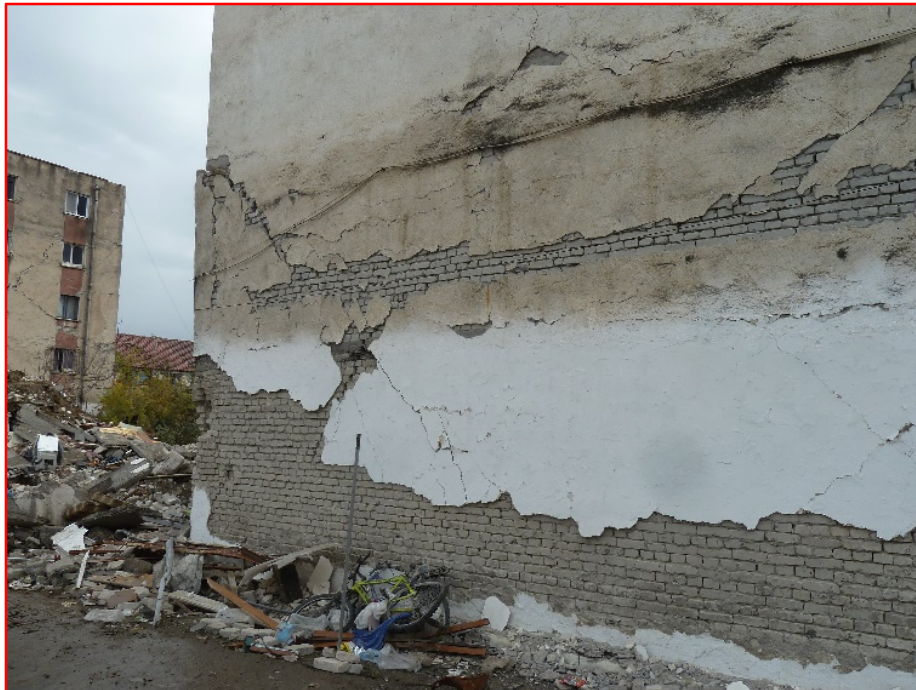
STRUCTURAL DAMAGE TO BUILDINGS WITH LOAD BEARING BRICK WALLS IN THUMANË TOWN

Heavy structural damage to buildings with load bearing solid brick walls and concrete floor slab in Thumanë town are presented. Damage comprised detachment of large pieces of plaster from the brick walls, cracks in brick walls and partial collapse of the building. The floor slabs were composed of simply supported prefabricated reinforced concrete hollow core strap slabs. The concrete strap slabs are not transversally connected to each other neither to the load bearing system. In this way, the diaphragmatic function of the floors, which is beneficial for the earthquake safety of the structure, is totally missing.

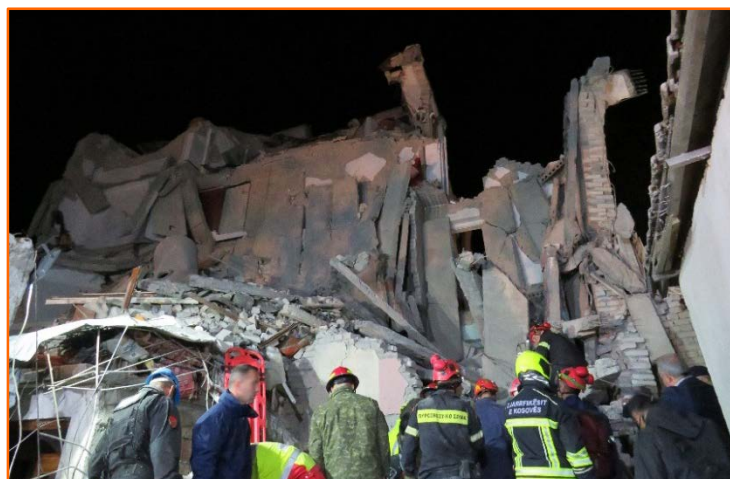
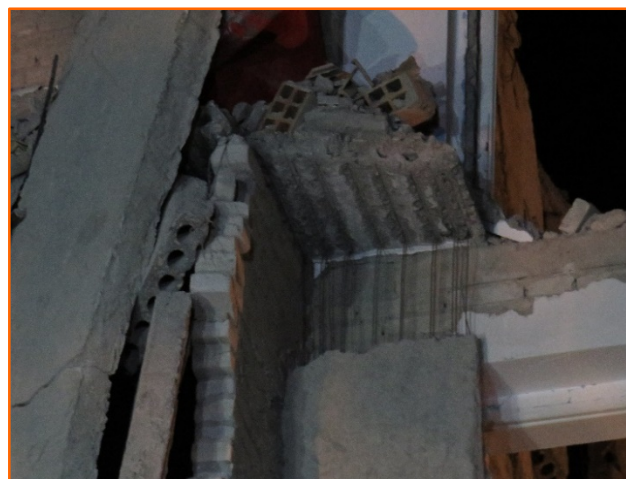
Based on the field macroseismic reconnaissance survey conducted after the September and November Durrës earthquakes, it is concluded that many buildings of all observed construction types used precast floor slabs. These slabs are prefabricated and then lifted with cranes or elevators. The slabs that were usually observed in collapsed or heavily damaged buildings mainly in Thumanë and secondarily in Durrës were simply supported prefabricated reinforced concrete hollow core strap slabs, not transversally connected to each other neither to the load bearing system. In this way, the diaphragmatic function of the floors, which is beneficial for the earthquake safety of the structure, is totally missing. These elements were subjected to the earthquake motion resulting in destruction.

The simple support of these precast elements is not allowed by modern earthquake codes due to the fact that in most cases the existing joints are not adequate and/or strong enough to undertake the vertical and horizontal seismic actions. The joints at the supports must be constructed in order to rigidly withstand the up-down jumping movement of the slabs and the differential horizontal displacements, i.e diaphragmatic function. The lack of these provisions in the joints may be the basic reason for numerous heavy structural damage and collapses of the buildings with precast floor slabs. Recent examples of this performance were also observed in buildings affected by the 2009 L' Aquila and 2012 Emilia - Romagna earthquakes in Italy (*Carydis et al., 2009, 2012*).

A collapsed building in Thumanë with load bearing brick walls and simply supported reinforced concrete hollow core slabs.

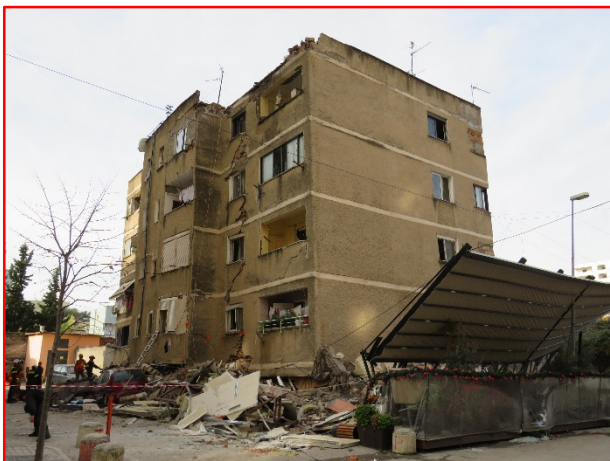
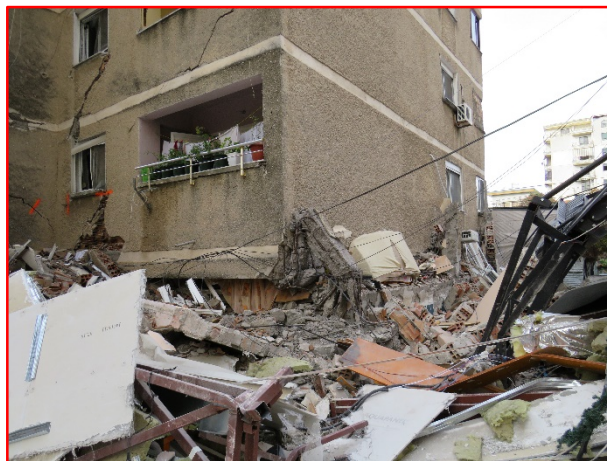
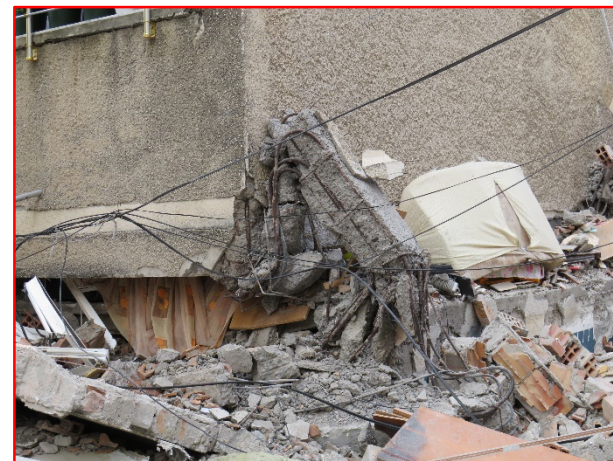
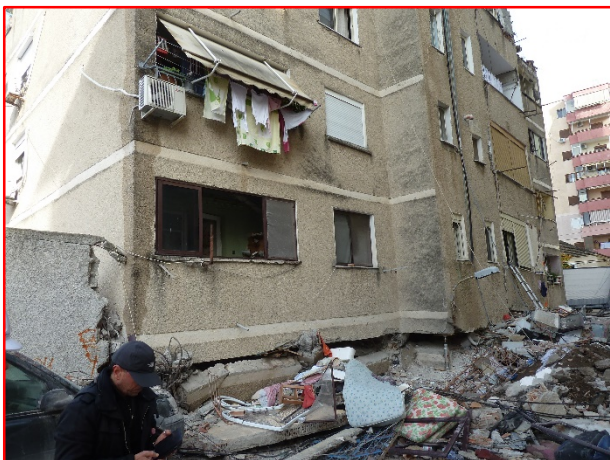
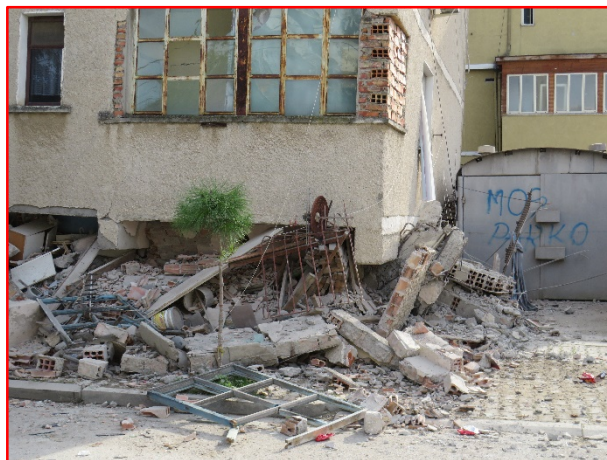
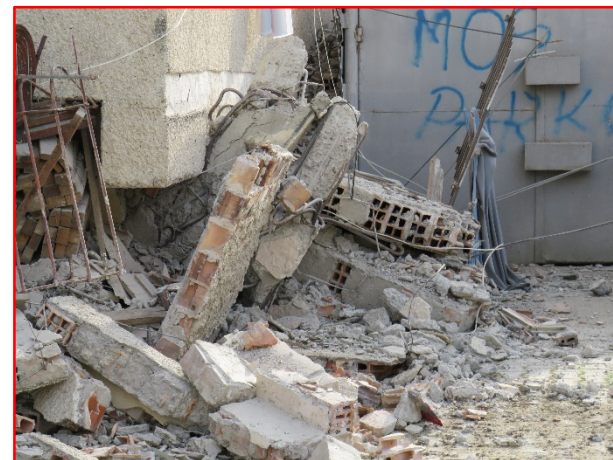
STRUCTURAL DAMAGE TO BUILDINGS WITH LOAD BEARING BRICK WALLS IN DURRËS CITY

Collapse of the two lower floors of the building. The deformation of the steel bars of the columns is attributed to the movement of the building under the effect of the dominant vertical component of the earthquake ground motion. This building is located in the area of the macroseismic epicenter, where the vertical component prevails over the horizontal one.

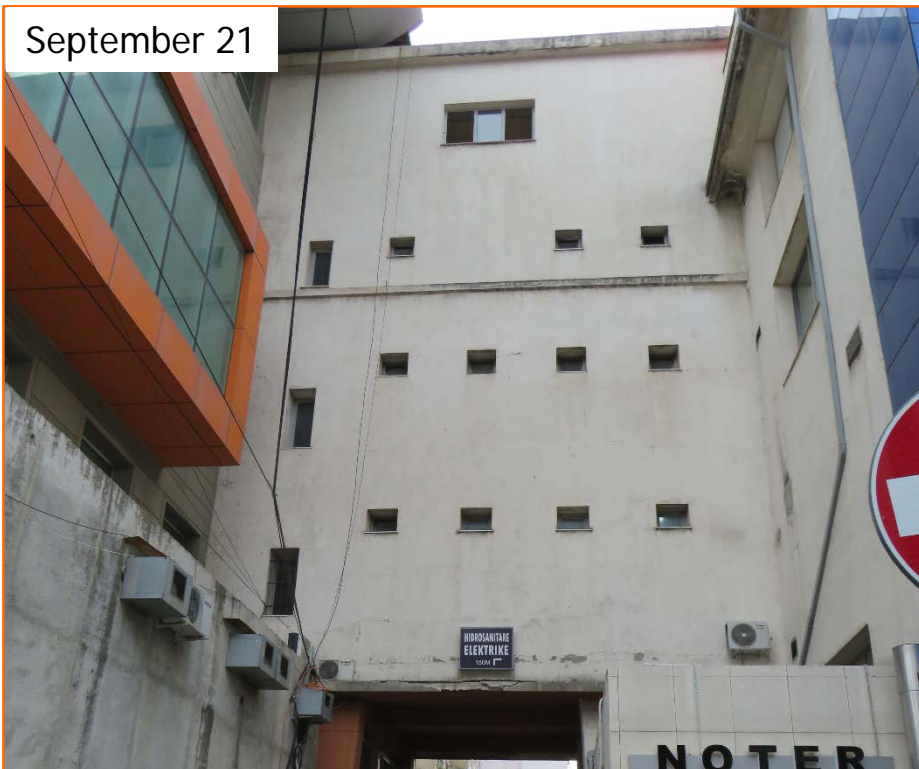
September 21

The building in Durrës remained almost intact from the September earthquake.

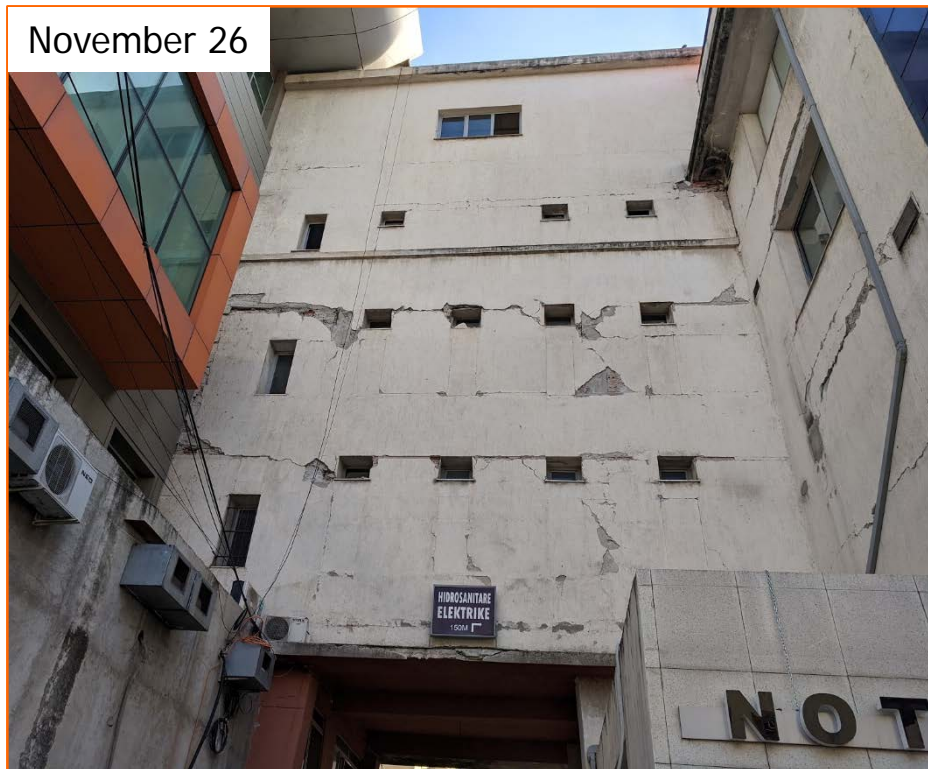
November 26

The building suffered non-structural damage from the November earthquake including cracks in the brick wall, detachment of pieces of plaster from the wall and detachment of the brick wall from the surrounding slabs. No damage was observed in the upper level of the building. This type of damage (horizontal and no X-formed cracks) indicates the prevalence of the vertical component of the earthquake ground motion.

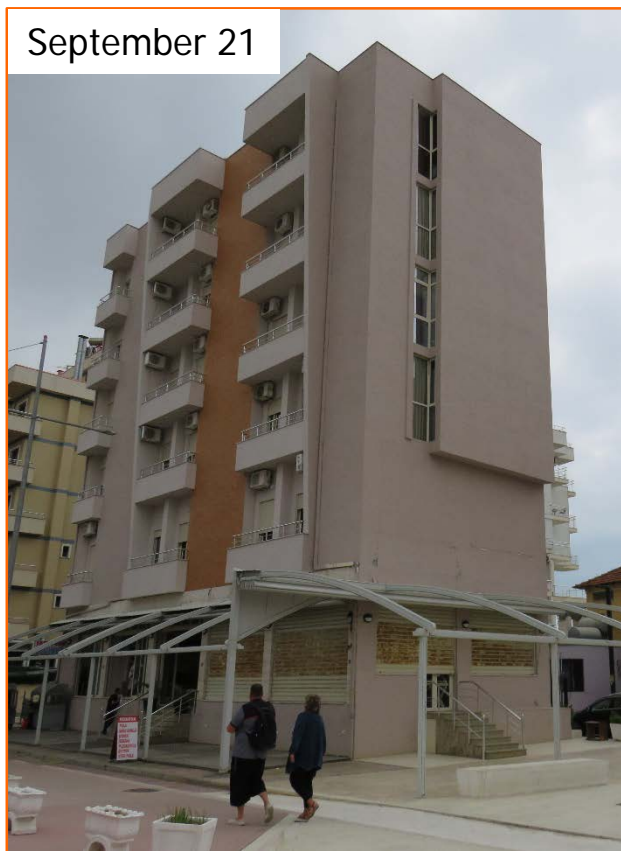
Separation of brick walls from the members of the RC framing system, which is a common phenomenon due to the deformational incompatibility between the two structural elements.

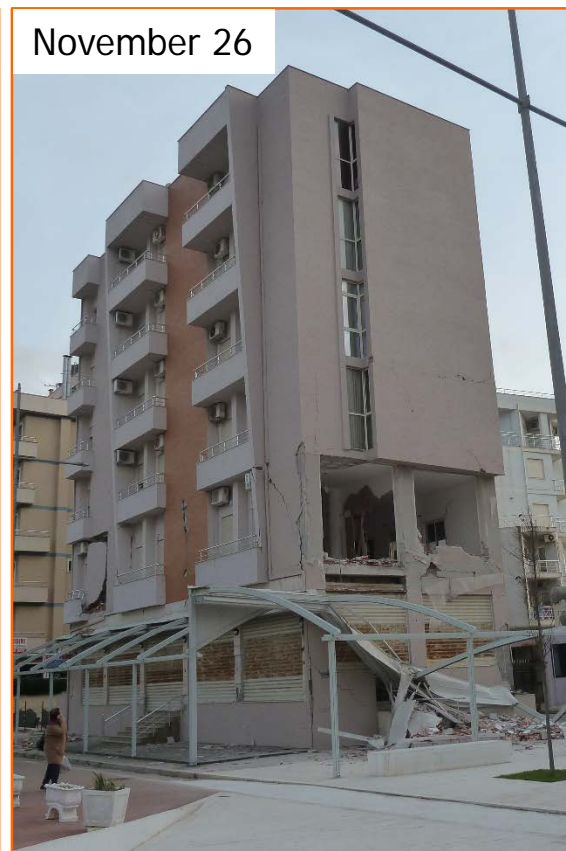
Total collapse of infill and partition brick walls from the members of the RC framing system. Damage are limited to the three lower storeys of the building.

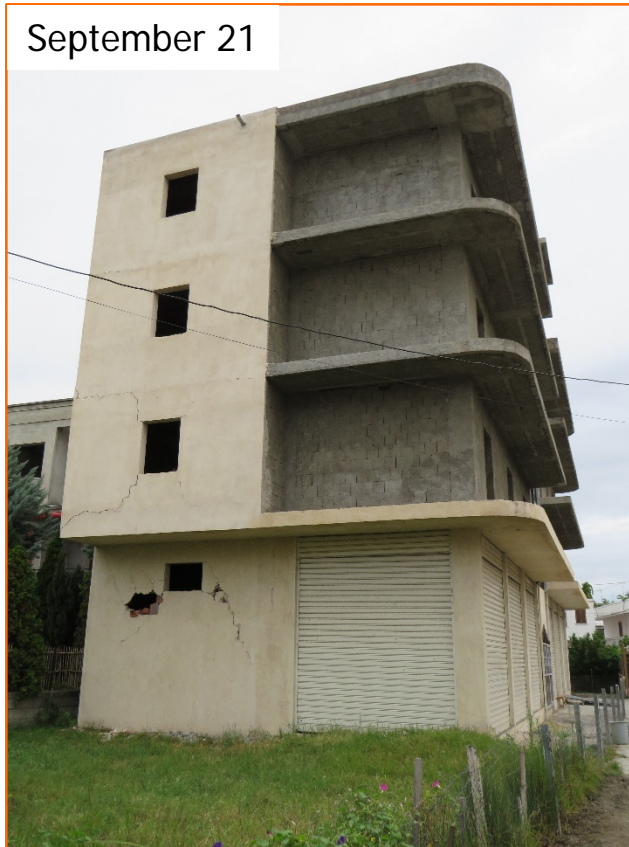
Effect of the vertical component of the earthquake ground motion in combination with the horizontal one on brick walls on an RC cantilever.

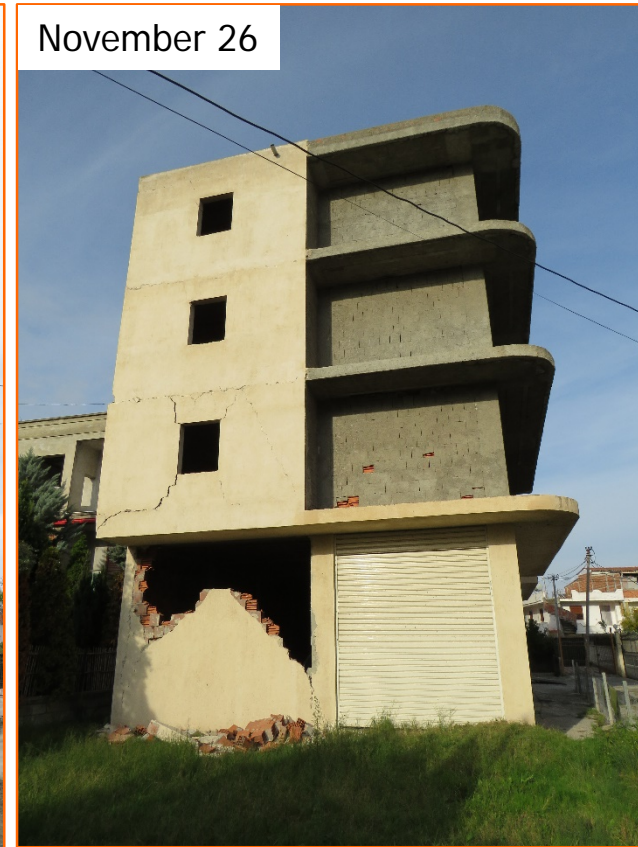
Partial collapse of the brick wall of the ground floor and light cracks.

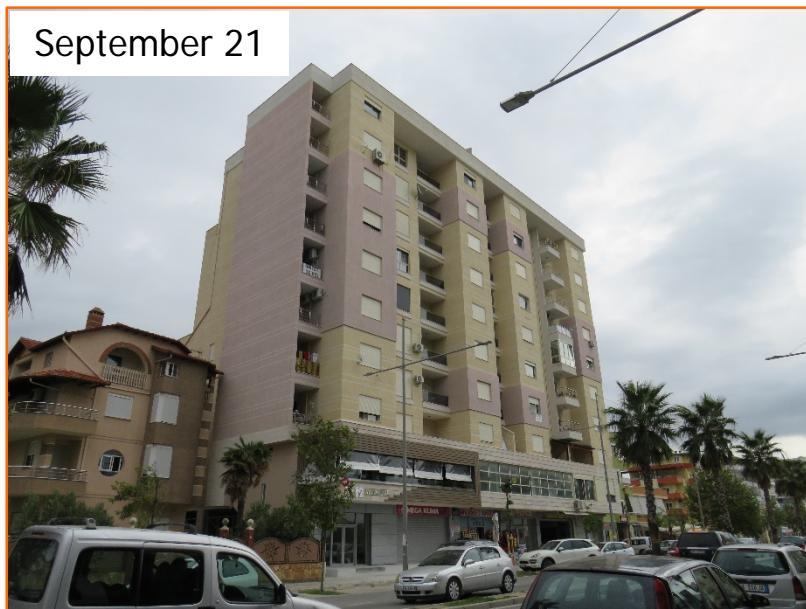
▲ No damage was induced to this building during the September earthquake.

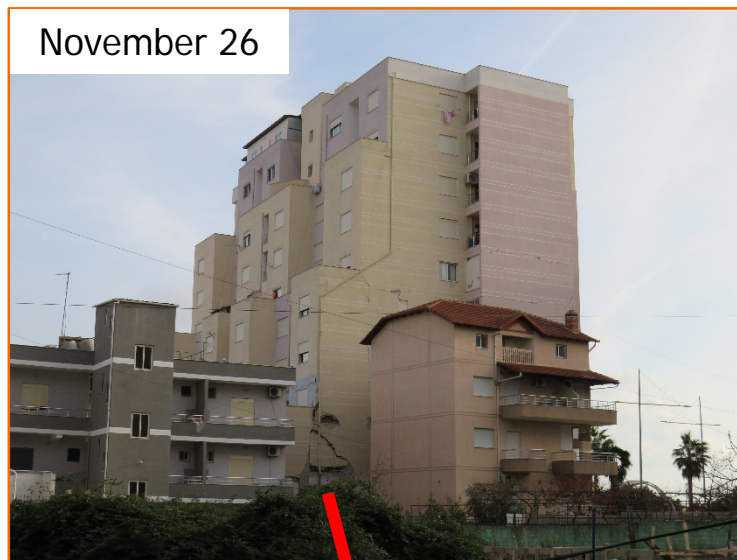
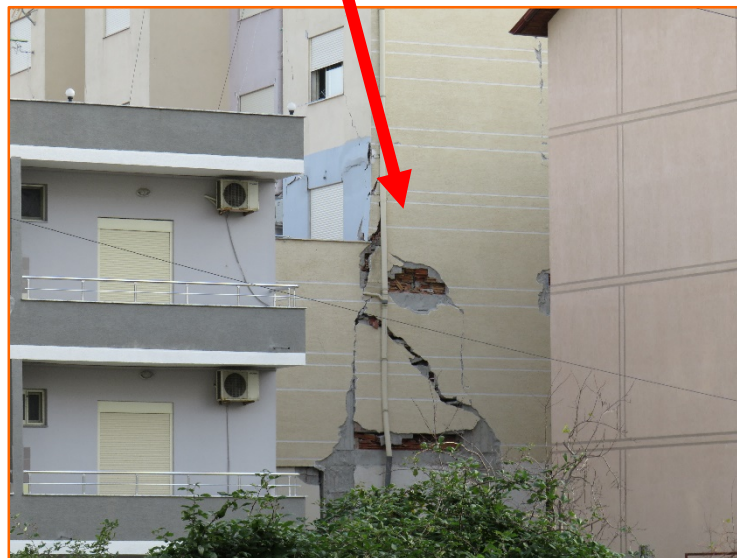
► The lower floors suffered heavy damage by the November 26 earthquake including partial collapse of the brick walls at the lower floors.

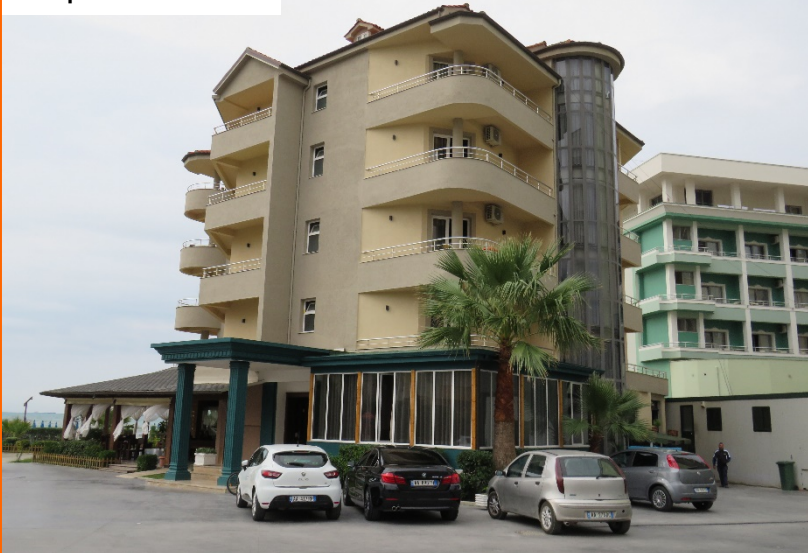
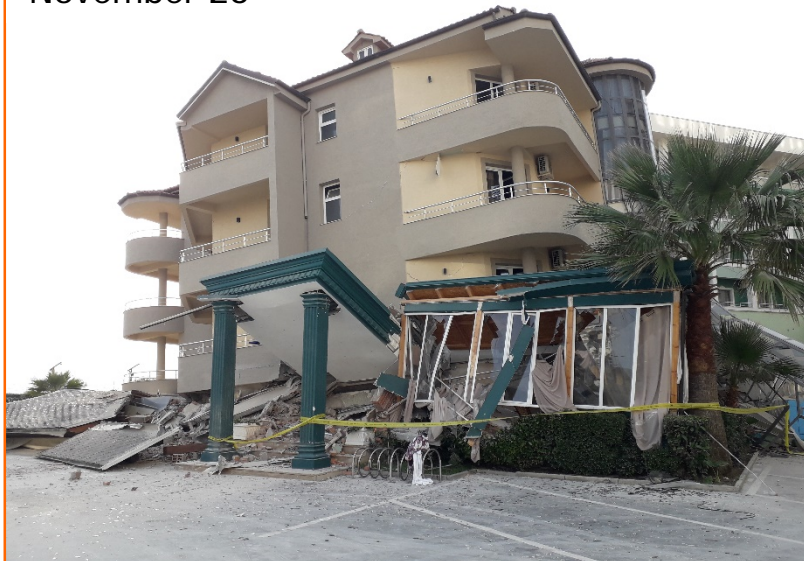
Hotel Vila Verde was founded on the coastal zone of Durrës, few meters from the sea. No damage was induced to the hotel during the September earthquake. The two lower floors totally collapsed during the November earthquake, while the structure above remained almost intact.

The area, where three hotels suffered very heavy structural damage, is one of the most affected areas by the November 26, 2019 Mw 6.4 earthquake. Mira Mare Hotel totally collapsed, Vila Verde Hotel partially collapsed and Lubjana Hotel tilted after column collapse and probably liquefaction.

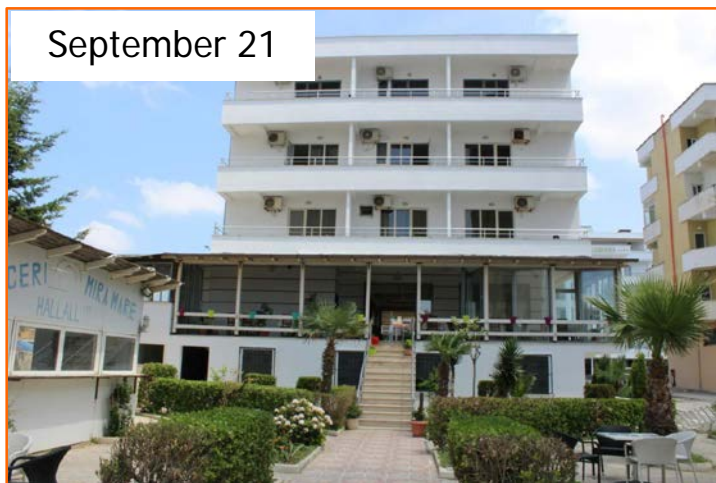
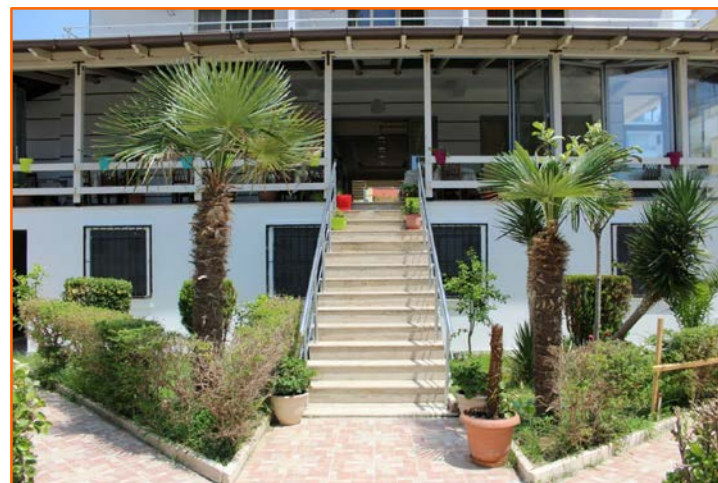
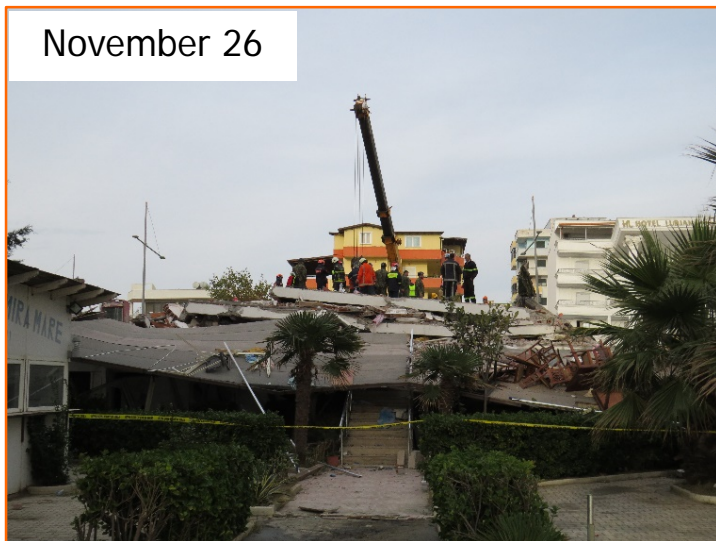
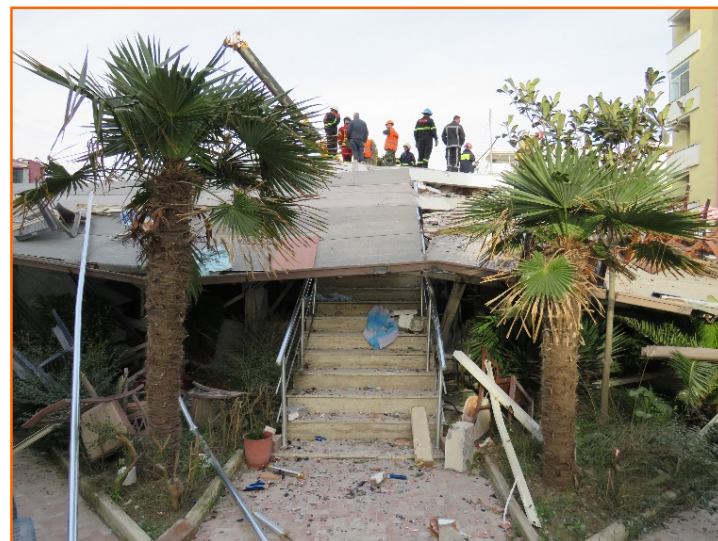
VERY HEAVY STRUCTURAL DAMAGE TO BUILDINGS IN DURRËS INDUCED BY THE NOVEMBER 26, 2019 EARTHQUAKE

Mira Mare hotel was founded on the coastal zone of Durrës, few meters from the sea. No damage was induced to the hotel by the September earthquake. During the November 26 earthquake, it totally collapsed.

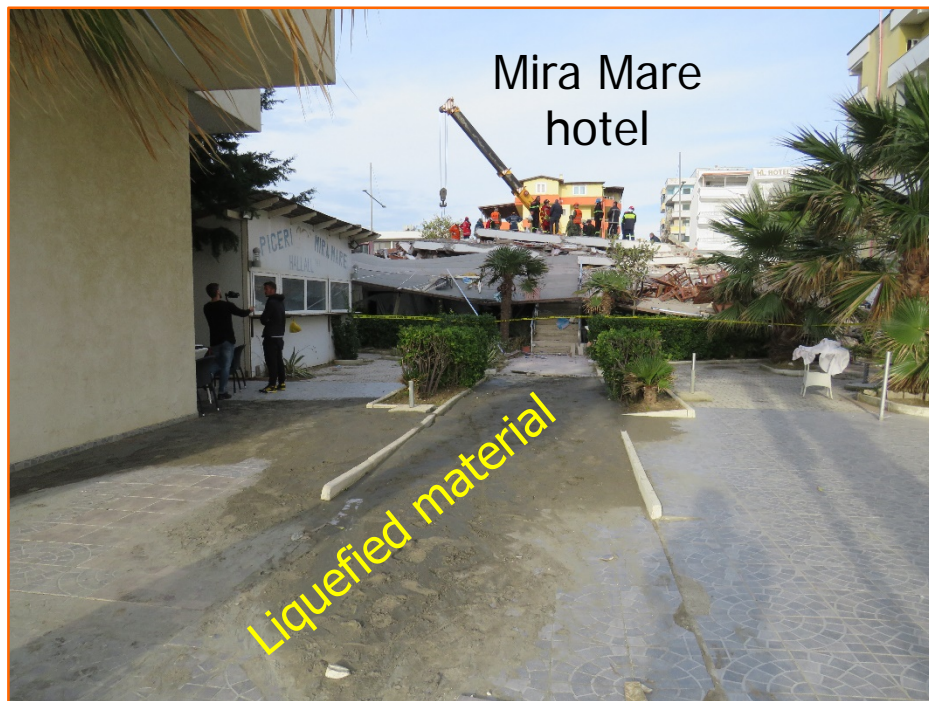
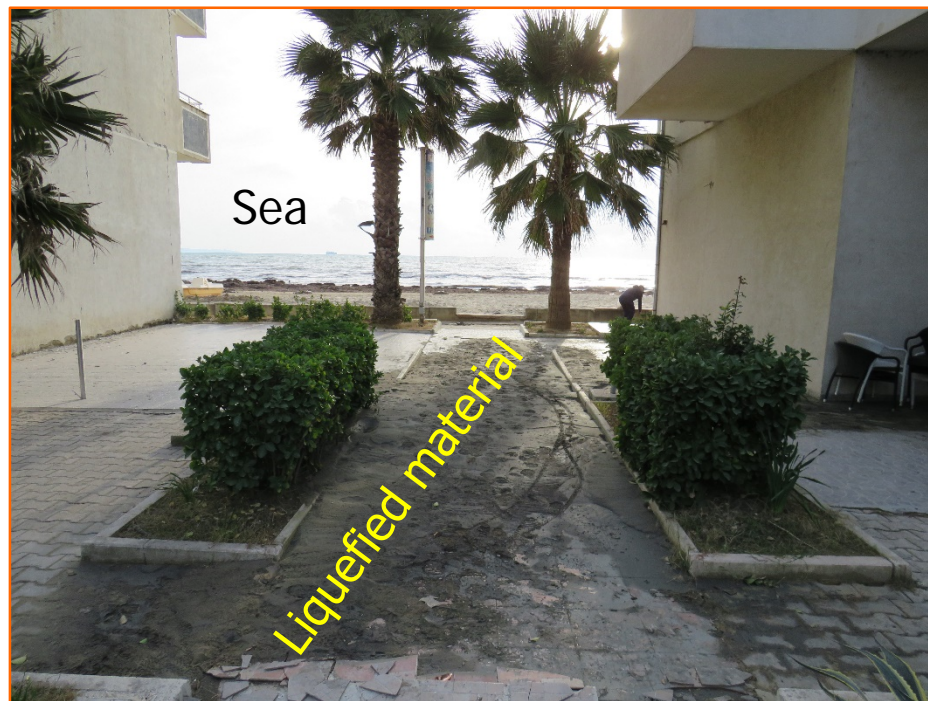
LIQUEFACTION PHENOMENA CLOSE TO A COLLAPSE SITE

Few meters from the collapsed hotel Mira Mare, liquefaction phenomena were generated. Sand boils erupted during the earthquake from ground cracks resulting in the formation of small sand volcanoes and silt-covered pavements. The liquefaction phenomena observed in this site may contribute to the initial sinking and tilting of the building that led to its final collapse.

Close to the Mira Mare Hotel liquefaction phenomena were generated comprising ejection of sand through cracks, formation of small sand volcanoes and silt-covered pavements. The site with the three heavily damaged buildings is close to the sea and is composed of unconsolidated recent deposits that constitute the soft ground of the area.

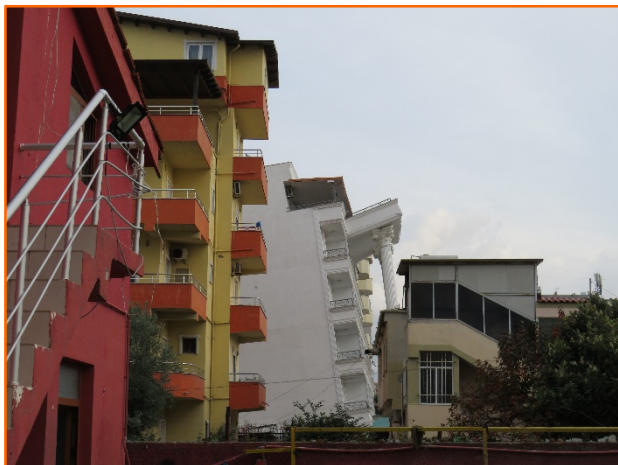
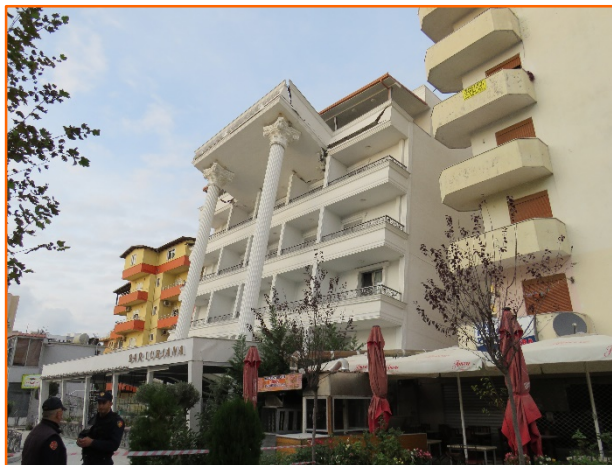
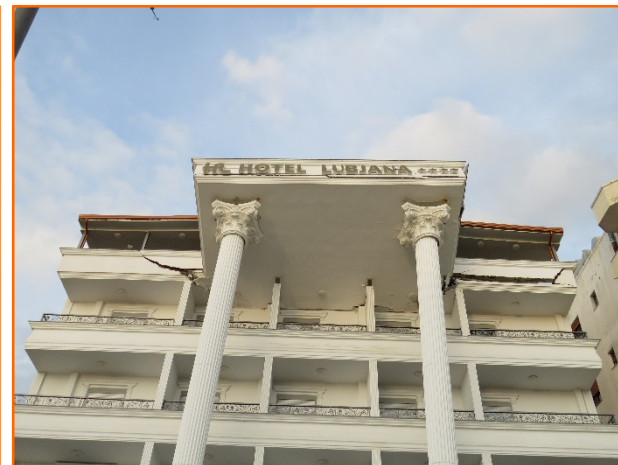
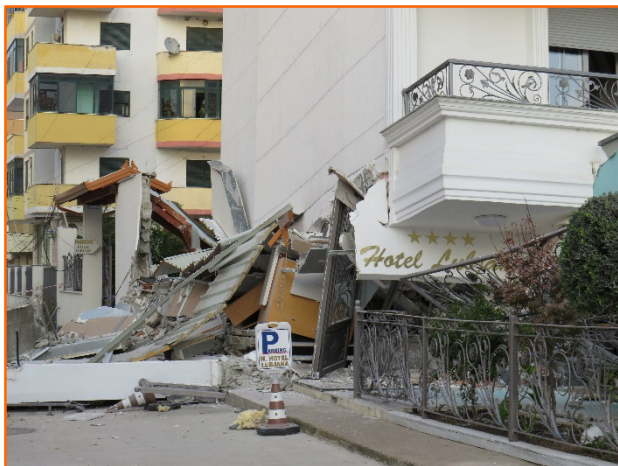
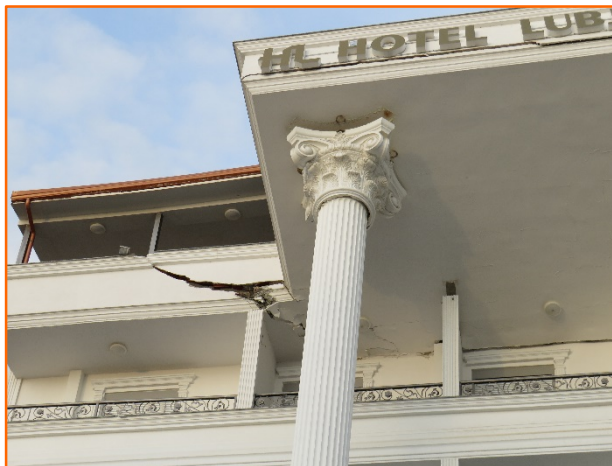
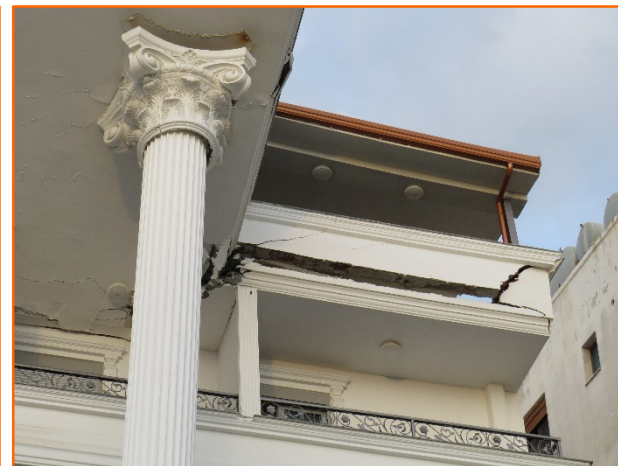
It is significant to note that the hotel Lubjana, located few meters from Mira Mare, presented tilting that might be attributed partially to the failure of the columns of the ground floor and partially to liquefaction phenomena, but it did not collapse.

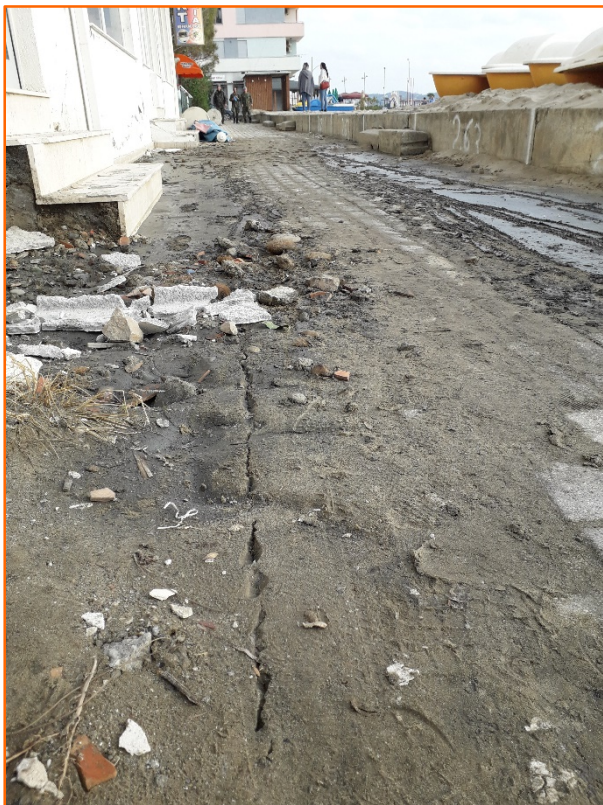
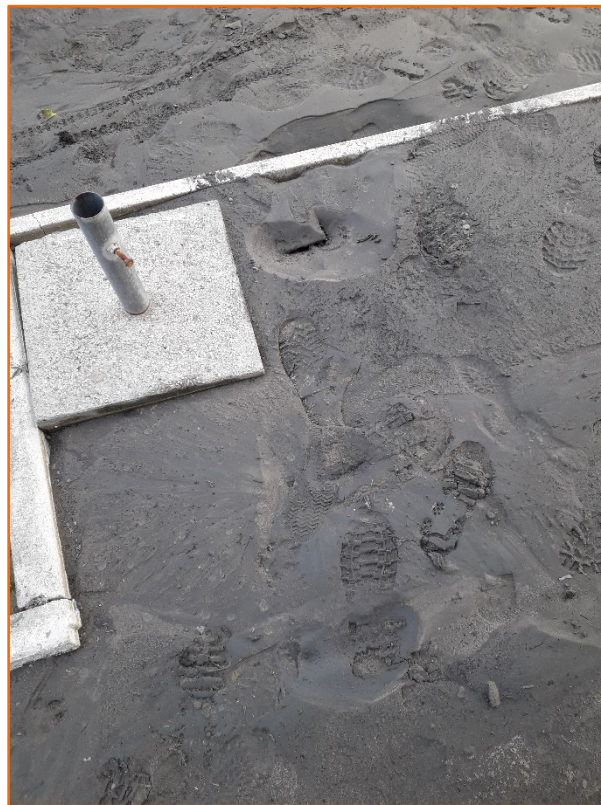
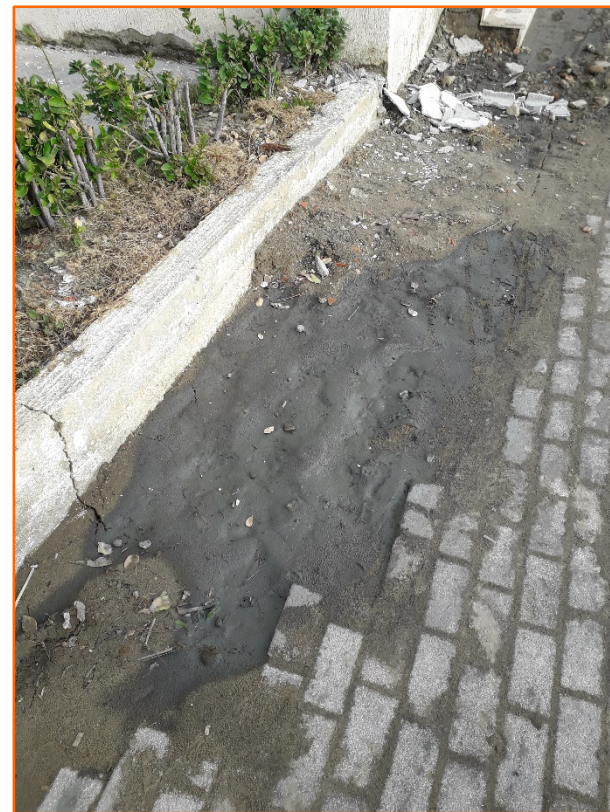
LIQUEFACTION PHENOMENA CLOSE TO A COLLAPSE SITE

Ejection of liquefied material through cracks resulting in small sand volcanoes and covered pavements. These liquefaction phenomena took place few meters away from the collapsed Mira Mare Hotel and other tilted buildings in the coastal Durrës. Small scale liquefaction phenomena were also generated in the coastal area of Durrës by the September 21, 2019 Mw 5.6 earthquake ([Lekkas et al., 2019](#), Newsletter of Environmental, Disaster, and Crises Management Strategies, Vol. 13)

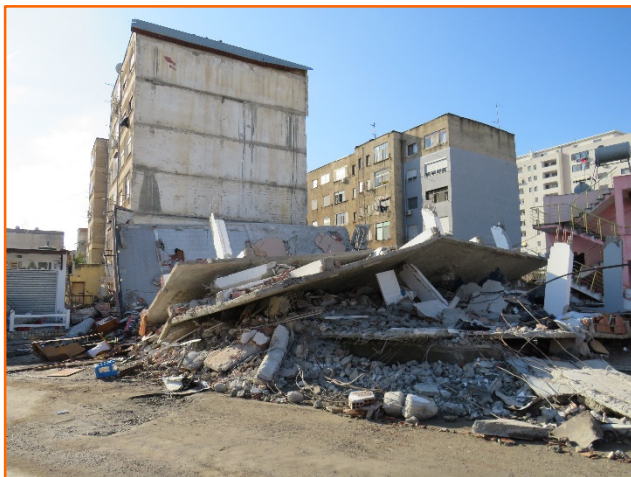
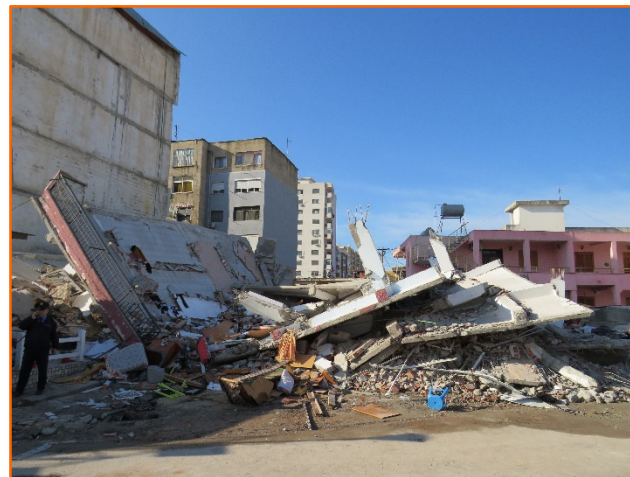
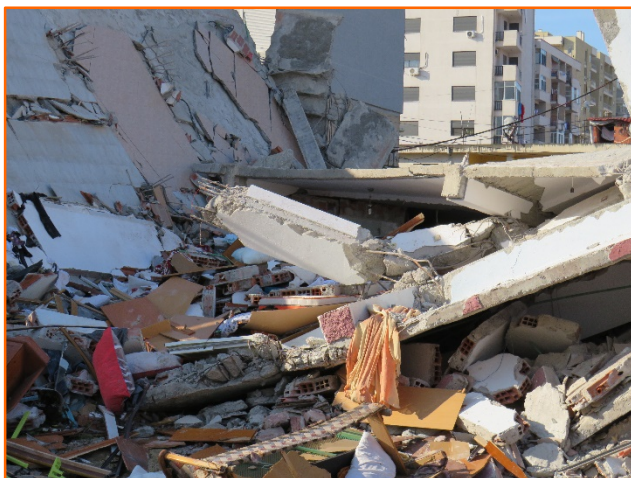
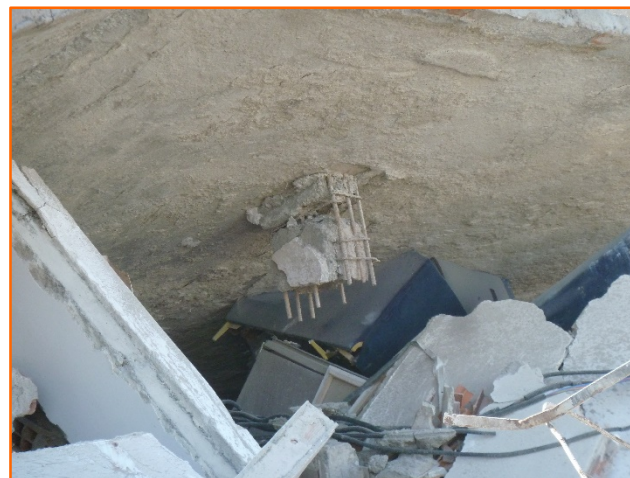
VERY HEAVY STRUCTURAL DAMAGE TO BUILDINGS IN DURRËS INDUCED BY THE NOVEMBER 26, 2019 EARTHQUAKE

A total collapse of a 5-storey building in Durrës. The short extensions of rebars in the columns of the first floor were only 30-40 cm long and adversely affected the performance of the building during the earthquake resulting in its collapse. The upper floors of the structure were overturned and crushed.

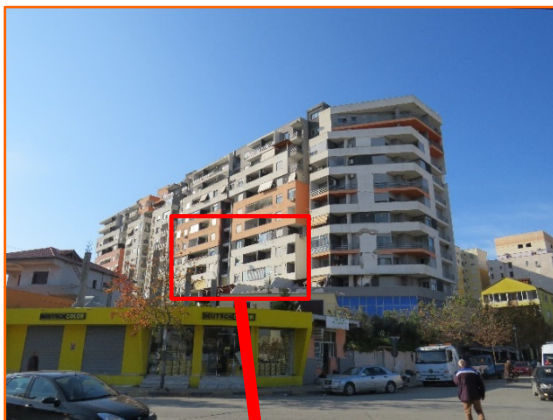
A multistorey building in Durrës with damage observed only in the three lower storeys, while the upper storeys remained intact by the earthquake. Cracking of plaster, detachment of plaster from the brick walls, cracking and partial collapse of brick walls were mainly observed. The adverse characteristics of this building comprise cylindrical and thin columns and almost triangular shape of the building in top view. Moreover, beams are totally missing, especially in the interior of the structure. This lack constitutes a rule in the affected area. The slabs are prefabricated reinforced concrete hollow core slabs with no connections between them.

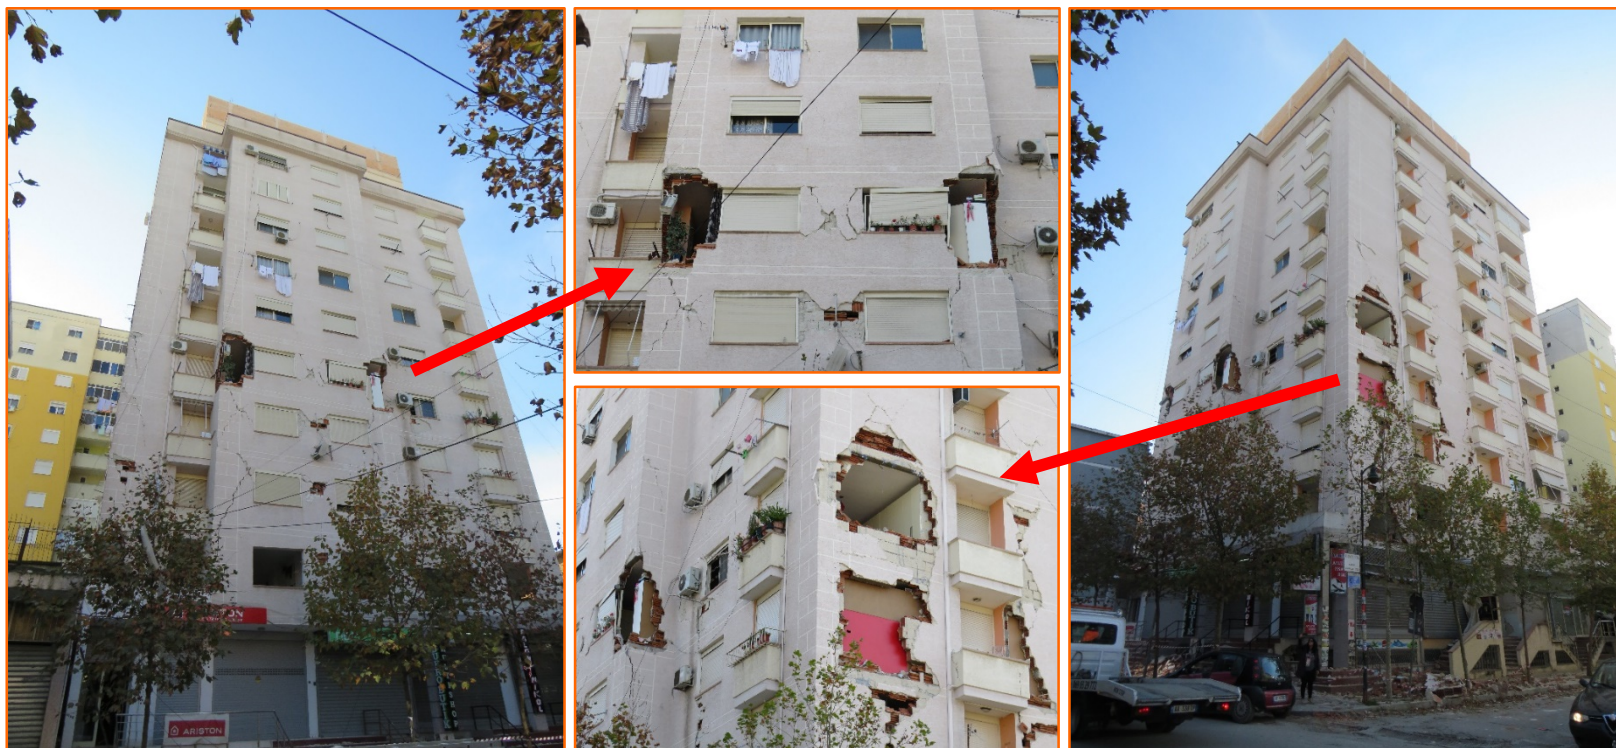
A multistorey building in Durrës with damage observed only in the four lower floors, while the upper floors remained intact by the earthquake. Cracking of plaster, detachment of plaster from the brick walls, cracking and total collapse of brick walls between slabs were mainly observed. Moreover, the equipment of the apartments including furniture and electric devices among others overturned and slid. The equipment of the apartments was overturned and slid. This fact is attributed to high internal accelerations of the floors (floor accelerations). This is a rare phenomenon around the world and it is in accordance with all the seismic regulations of several countries. It is attributed to the action of a strong vertical component of the earthquake ground motion, which prevails in epicentral areas. However, this phenomenon is not rare in Greece and Italy due to the fact that most of the earthquakes that have struck these countries during the last decades have been shallow, moderate to strong seismic events with their epicenters located close to large urban areas.

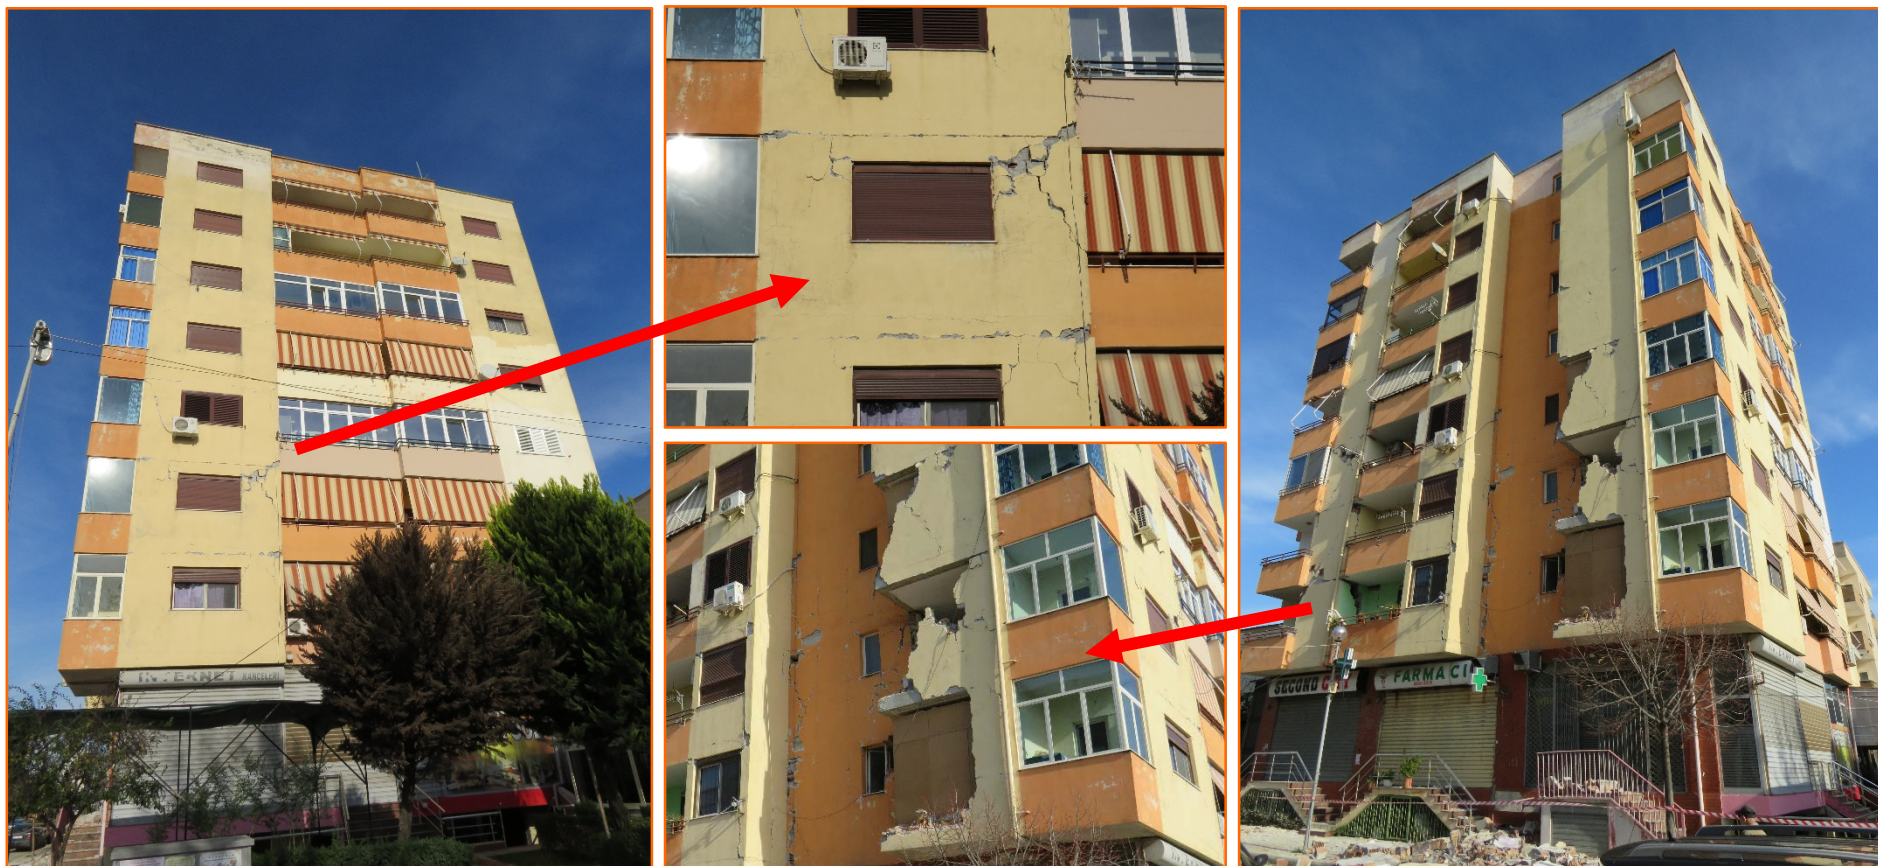
A multistorey building in Durrës with damage observed only in the four lower floors, while the upper floors remained intact by the earthquake. Cracking of plaster, detachment of plaster from the brick walls, cracking and total collapse of brick walls between slabs were mainly observed. Moreover, the high plaster thickness generated sandwich walls and attracted seismic load that they could not resist.
