Newsletter of **Environmental, Disaster, and Crises Management Strategies**

Issue No.15 | November 2019

The November 26, 2019 Mw 6.4 Durrës (Albania) earthquake

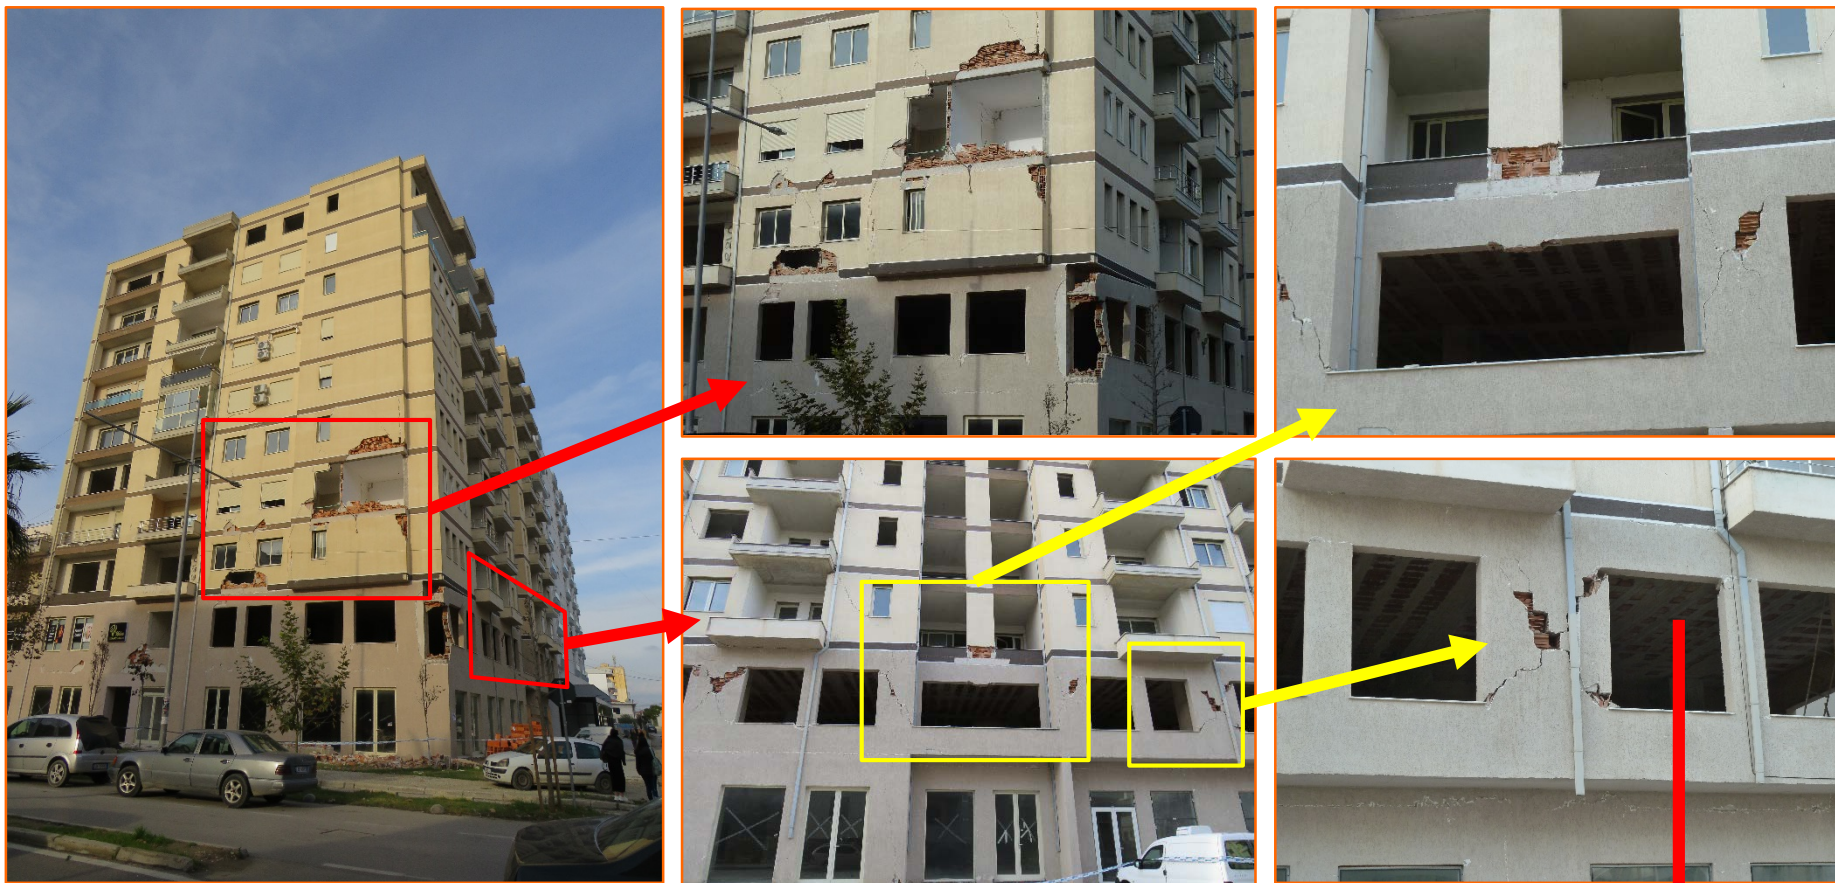
A multistorey building in Durrës with damage observed only in the lower floors, while the upper floors remained intact. Cracking of plaster, detachment of plaster from the brick walls, cracking and total collapse of brick walls between slabs were mainly observed. Exterior non-structural walls made of hollow clay bricks outside the reinforced concrete frame suffered damage. Floor systems consist mainly of brick units and concrete beams.

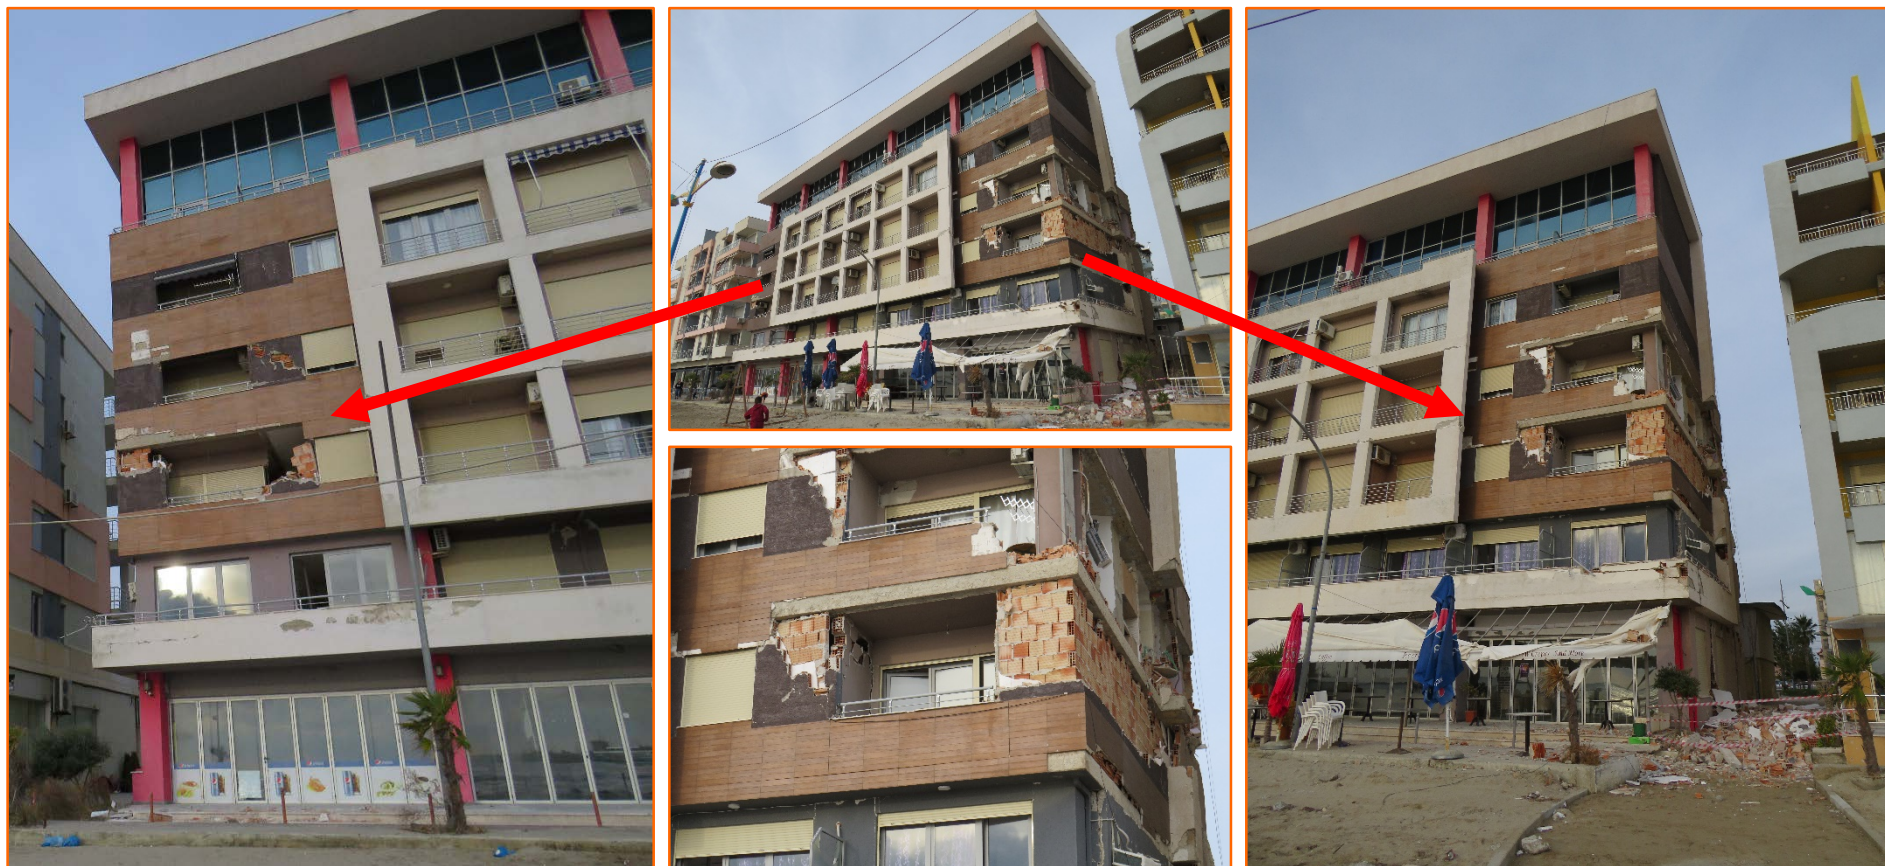
Exterior non-structural walls made of hollow clay bricks outside the reinforced concrete frame suffered damage

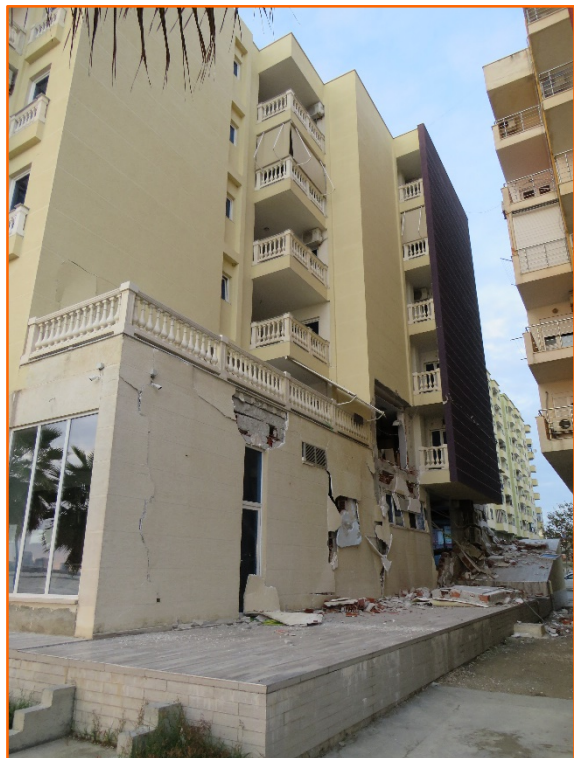
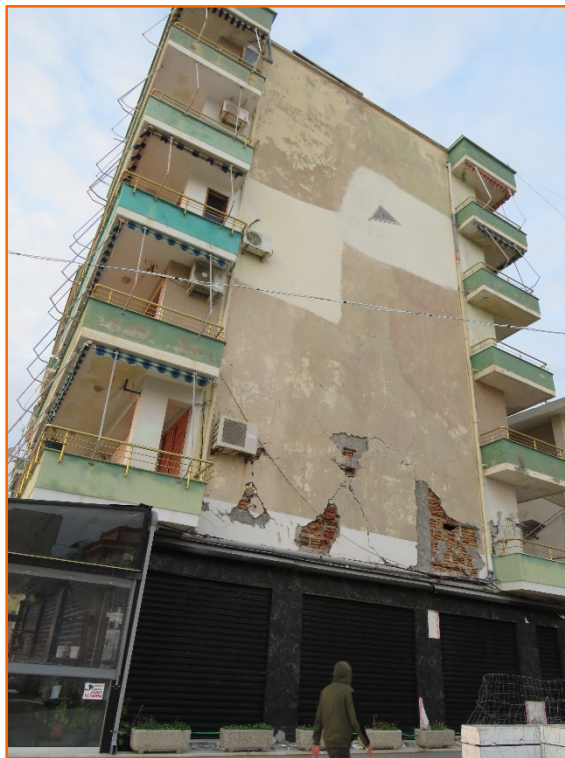
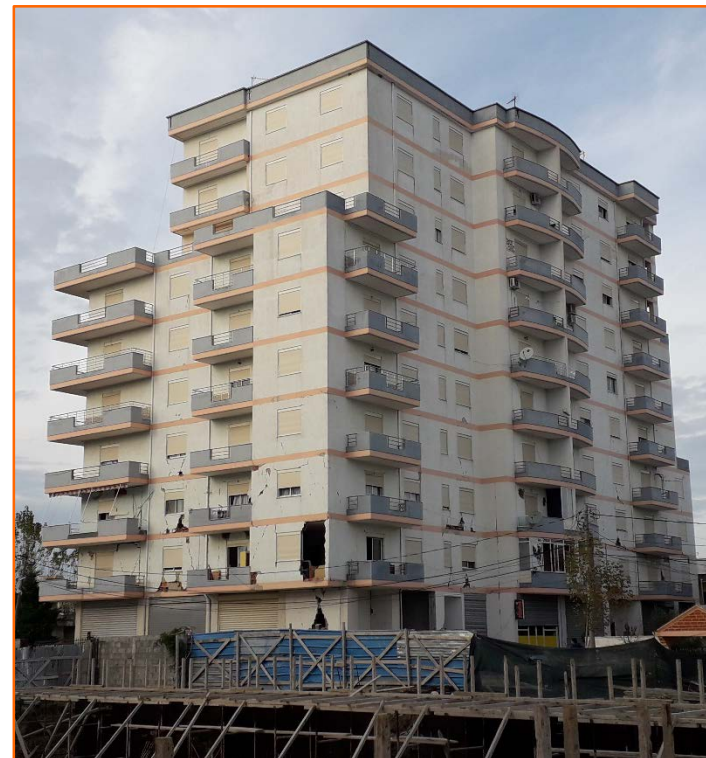
It is significant to note that the high-rise buildings were damaged on their lower floors. Moreover, the same floors have been destroyed, indicating high floor accelerations, which is a rare phenomenon in relation to the intact upper floors. This is probably due to the action and prevalence of a strong vertical component of the earthquake ground motion in the affected areas. In this case, due to the shallow water table, the S waves are not easily propagated, while the P waves in the water are easily propagated with very small attenuation. In addition, such buildings have large fundamental period with a high base height ratio.

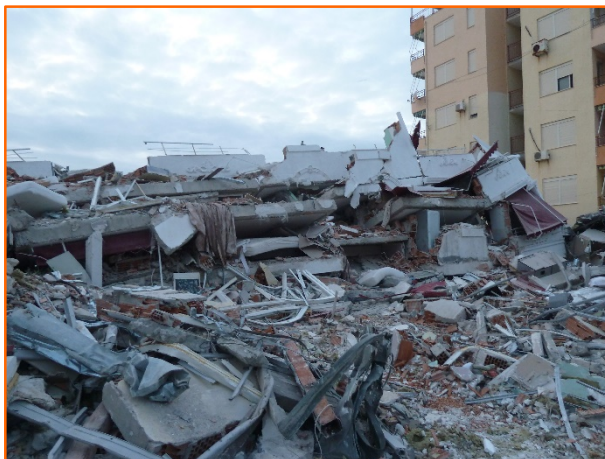
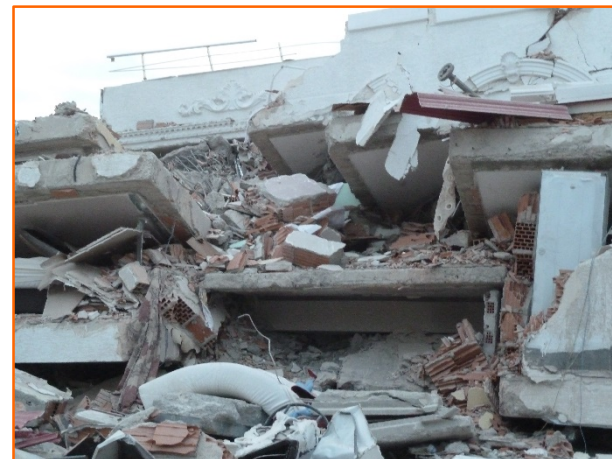
Hotel

The presented residential building (upper photos) and the hotel (lower photos) were among the totally collapsed buildings in Durrës. The destruction was almost complete with collapsed slabs leaving no gaps and empty spaces between them. The tangled mass of earthquake building debris reflects not only the strong seismic motion but also the poor construction of buildings and the inadequate quality of construction materials.
