**A preliminary
report on the Nov
17, 2015 M=6.4
South Lefkada
earthquake,
Ionian Sea, Greece**

December 4
2015

Athanassios Ganas,
Pierre Briole, George
Papathanassiou,
George Bozionelos,
Antonio Avallone,
Diego Melgar,
Panagiotis Argyrakis,
Sotirios Valkaniotis,
Evangelos
Mendonidis,
Alexandra Moshou
and Panagiotis Elias

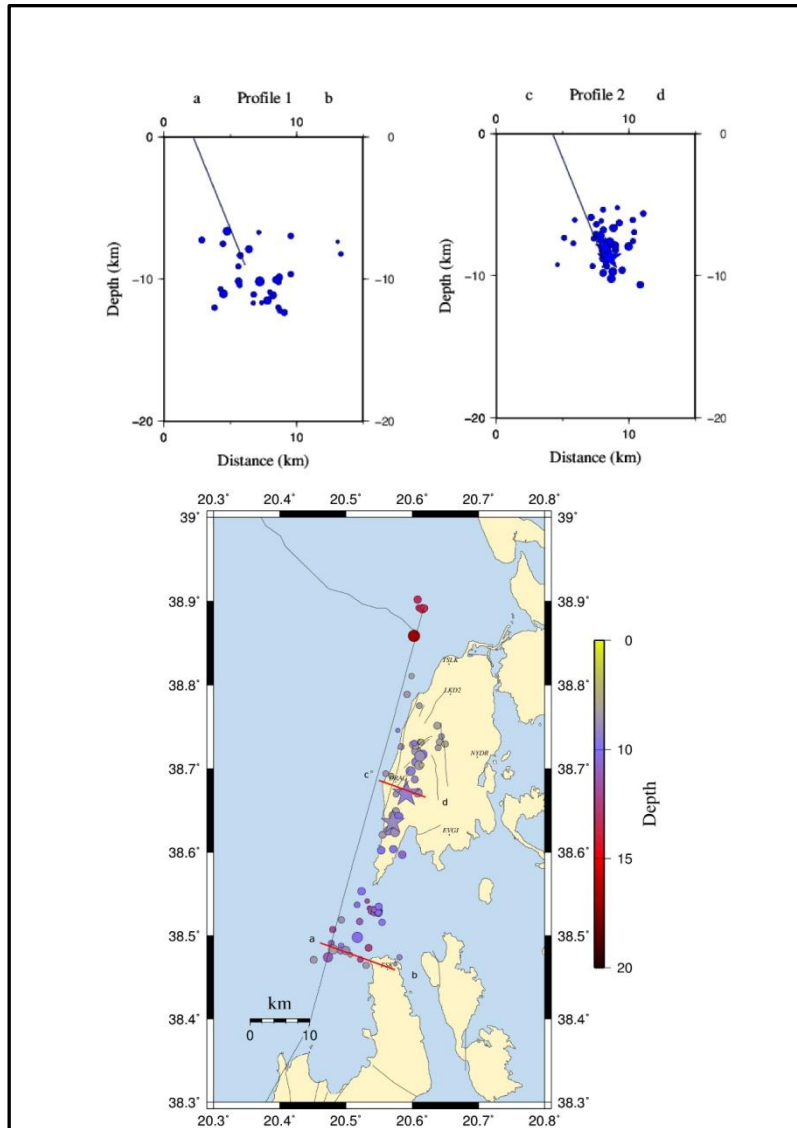
Figure 3. Map of relocated seismicity using NOA phase data (bottom) and E-W cross sections near the epicentre (top right; section c-d) and at the south end (top left; section a-b), respectively. Software used: NonLin-loc.

A few hundred events were relocated by use of the software NonLin-Loc (Lomax et al., 2000). The selection criteria used were a) azimuthal gap <math> < 180^\circ </math>, b) minimum number of phases per event 4 P-wave and 3 S-wave, c) solution rms <math> < 0.48s </math>, d) error on the horizontal

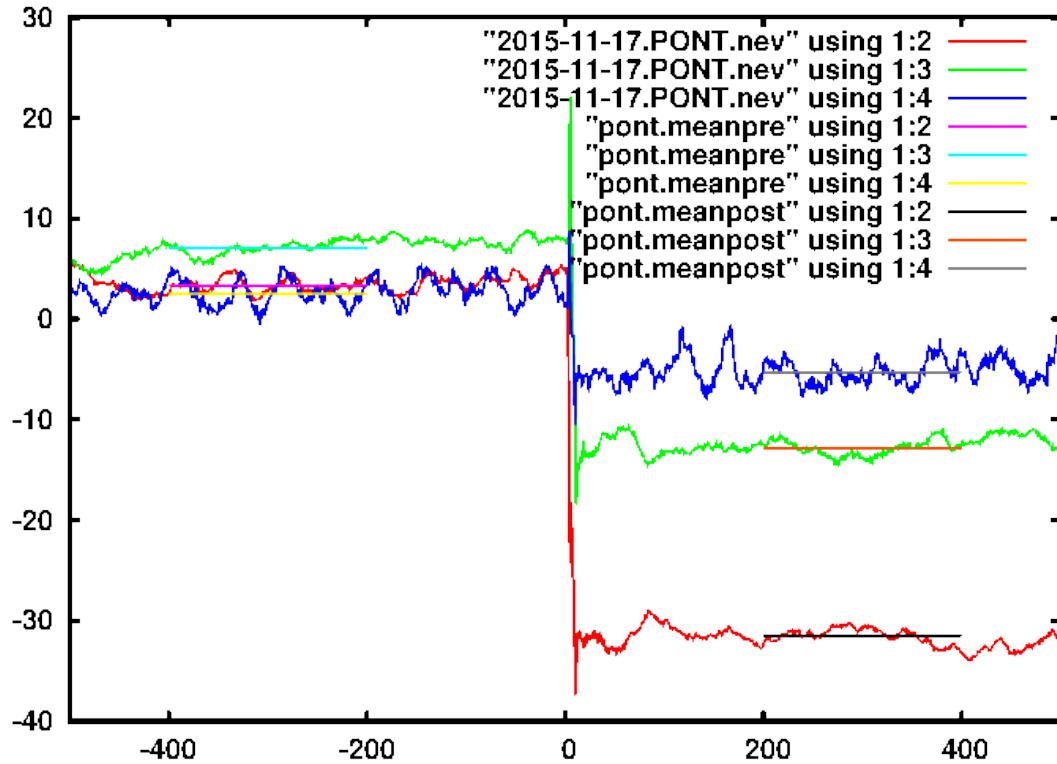
Figure 4. Graph showing static offsets of NOA station PONT (South Lefkada). Each time series shows the time window in which the average position (and the relative standard deviation) before and after the event have been computed. X-axis is time (s), Y-axis is displacement (cm).

According to the model obtained with the GPS vectors, the maximum land subsidence is 60 mm in the Vassiliki harbor (see Figure 4, blue line). Along the west coast of Lefkada the expected vertical displacement ranges between -30 and +16 mm, and the northern coast of Cephalonia, near the southern end of the fault might have been uplifted by 10 cm according to the model (constrained by the InSAR fringes observed in Cephalonia).

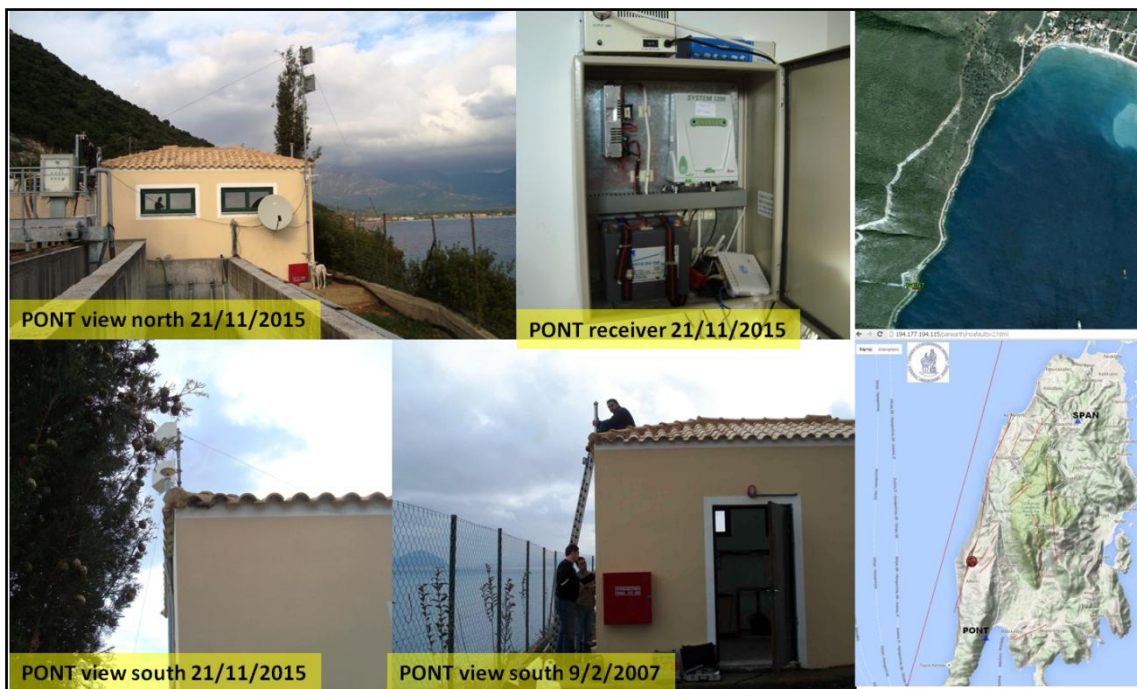
Figure 5. Picture mosaic of field photos + location of NOANET station PONT in Vassiliki area, south Lefkada.

The National Observatory of Athens during the last 10 years has established several permanent GPS stations in central and western Greece in order to monitor the tectonic motion (Ganas et al., 2008, 2011). In western Greece there are six stations that operate since early 2006 – mid 2007 (VLSM, RLSO, PONT, SPAN, KASI, KIPO; see www.gein.noa.gr/gps.html for network map and site logs). Ganas et al. (2013) presented results showing N-S crustal shortening onshore Lefkada Island of the order of 2-3 mm/yr, which the authors evaluated as “*is probably related to increased locking on the offshore Lefkada fault*” implying pre-seismic deformation. This report presents results from data provided by two (2) permanent GPS stations onshore Lefkada (SPAN and PONT) ¹ and one station in Cephalonia (VLSM). Our preliminary results include: time series of 1-s positions for stations SPAN, PONT (Figure 4) and static offset estimates (Table 1) due to seismic motion of Nov. 17, 2015 event. Figure 5 shows field photographs of station PONT in south Lefkada.

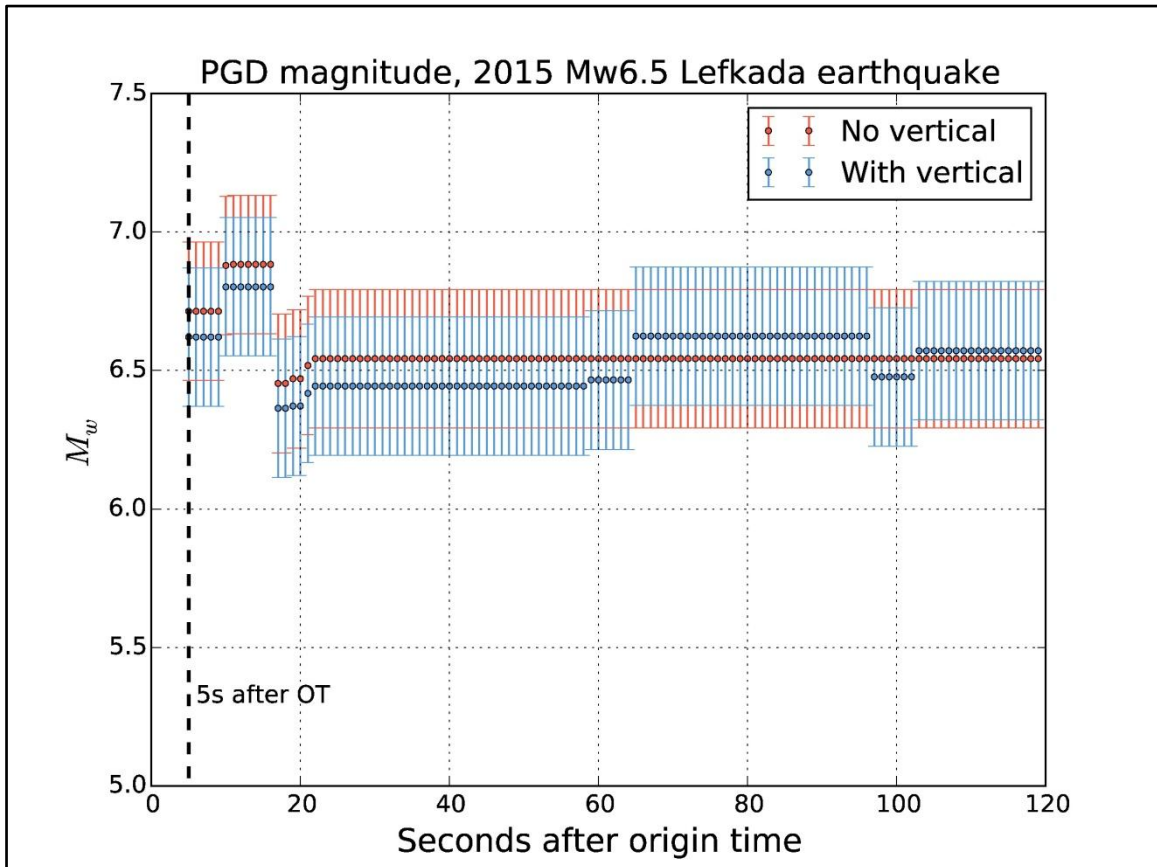
Figure 6. Plot showing the estimated moment magnitude ($M_w=6.5$) from the high-rate GPS as a function of time with uncertainties. First estimate is at only 5s after origin time.

The PGD magnitude of this event (as defined in Melgar et al., 2015; Figure 6) equals to $M_w=6.5$ and it works exceedingly well in this case thanks to the proximity of the permanent GPS stations to the epicentre. First estimate is at only 5s after origin time. The measurement stabilizes after 20-s. Neglecting data from the vertical components provides a more stable solution, however both solutions are quite good.

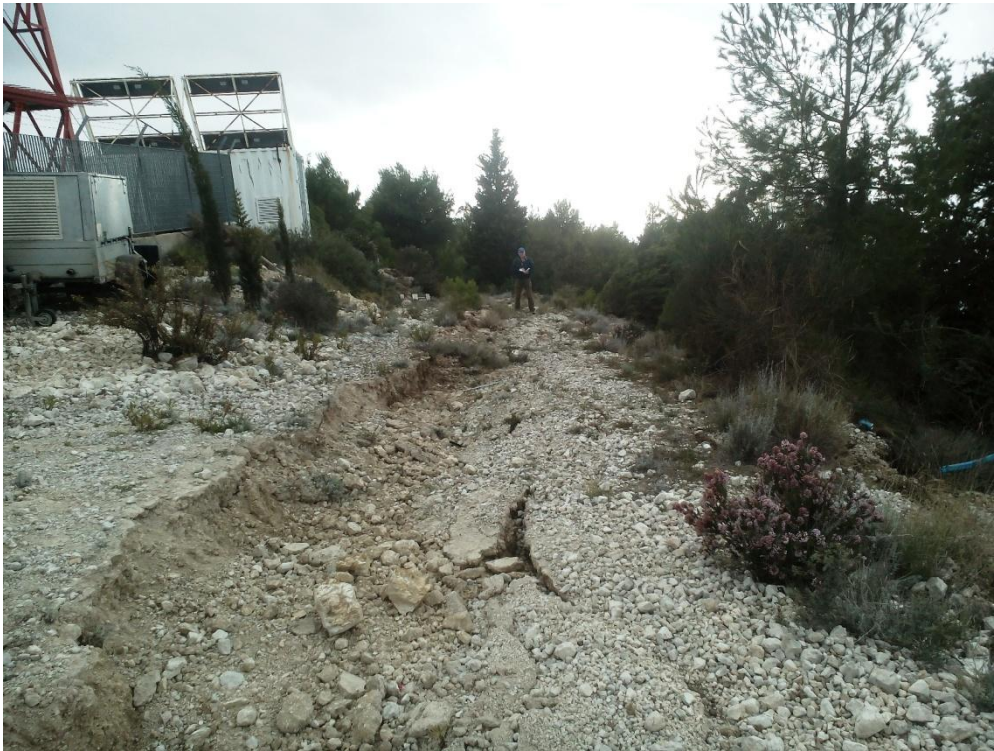
Figure A1. Field photo of landslide to the west of Dragano village. View to the south. Date photo was taken 22 Nov. 2015.

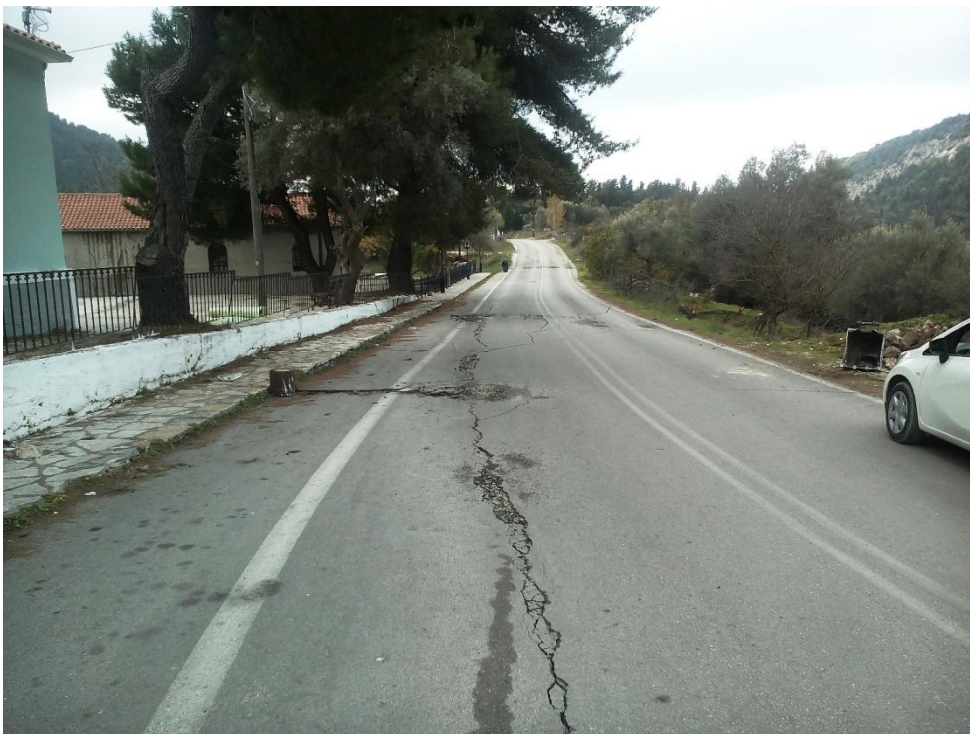
Figure A2 . Field photo of asphalt cracks along the road between Dragano and Athani villages. View to the south. Date photo was taken 20 Nov. 2015.

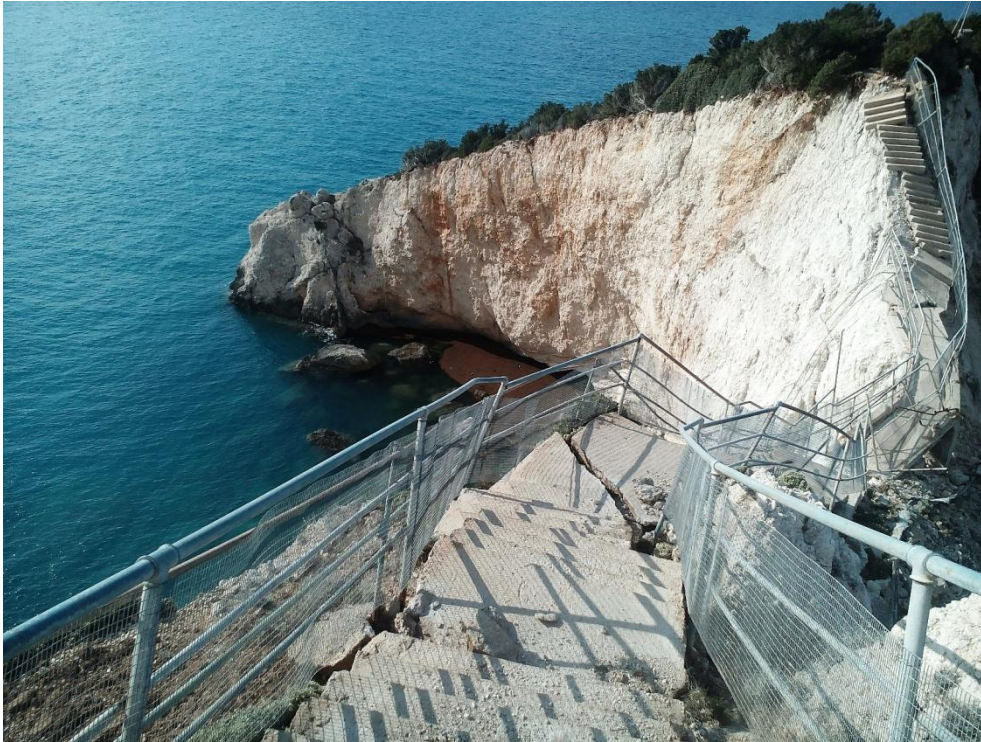
Figure A3 Field photo of damaged path to Porto Katsiki cape. View to the west. Date photo was taken 20 Nov. 2015.

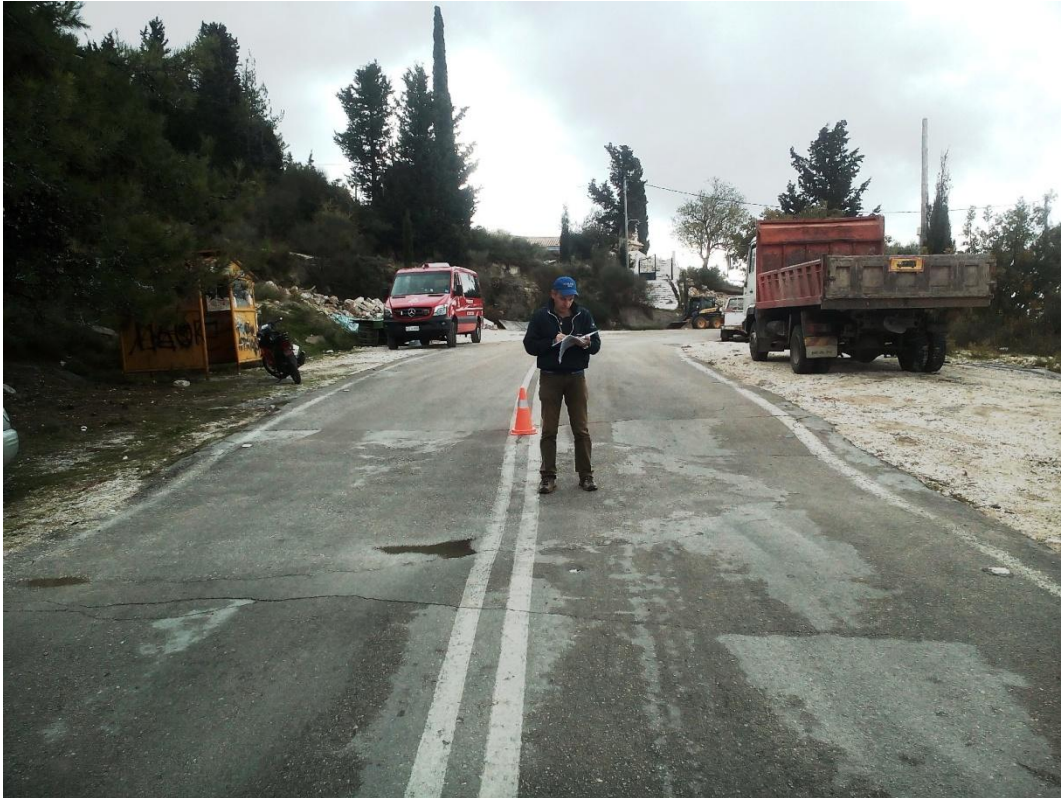
The dominant geoenvironmental effects triggered by the 2015 Lefkada earthquake were related to slope failures. Rock falls and shallow landslides were widespread on the western part of the island and at the central area, on both natural and cut slopes. The most densely concentration of these type of earthquake-induced ground deformations was reported on the coastal zone from Porto Katsiki to Egremnoi beach and along the 6 km long road of Tsoukalades- Ag. Nikitas, and are accompanied by small and large-size rock falls, rock mass slides and shallow landslides. In most cases, rock falls are directly associated with pre-existing tectonic discontinuities and steep slopes within sedimentary rocks. The shallow landslides were mainly generated in areas where the clastic material covered the bedrock and particularly in places where the rock mass was heavily jointed. It should be pointed out that this zone has been classified as very susceptible to slope failures by Papathanassiou et al (2013). Furthermore, cracks on paved roads were observed along the road network at the central and western part of the island, mainly within the zone that has been previously mentioned. One of the most representative cases of this type of failure has been observed at the entrance of village Athani, resulted to the closure of this road.

Figure A6 Field photo of damaged road at the entrance of Athani village. View to the south. Date photo was taken 21 Nov. 2015.

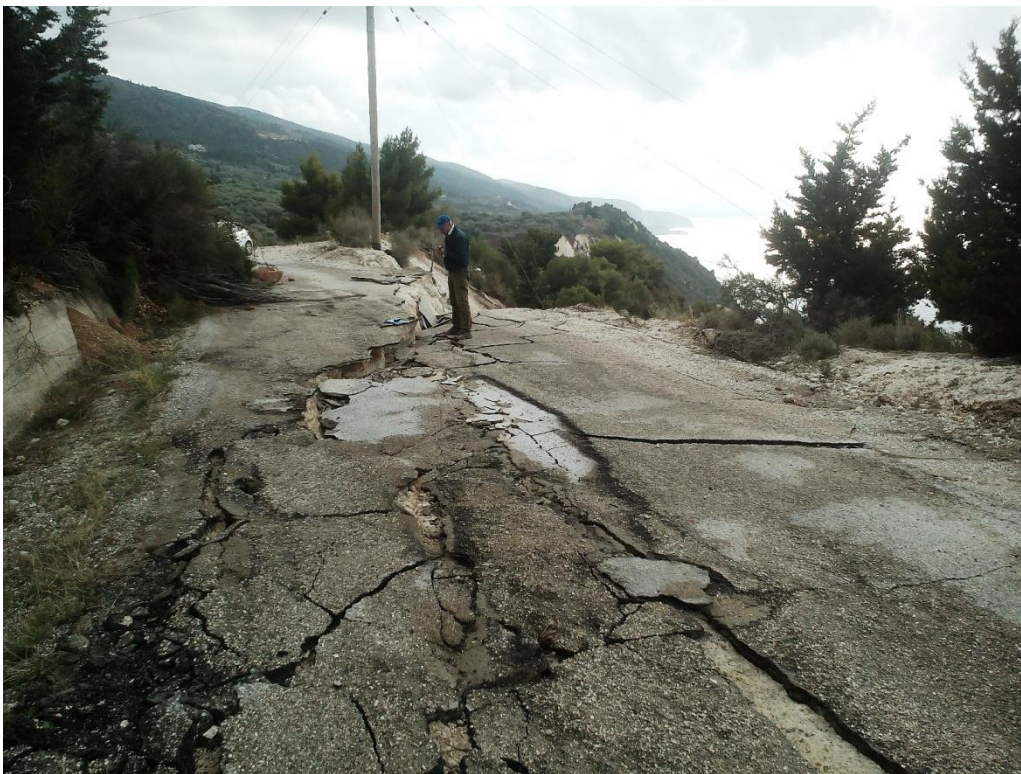
Figure A7 Field photo of damaged road due to landslide at Platys Gialos beach. View to the south. Date photo was taken 21 Nov. 2015.

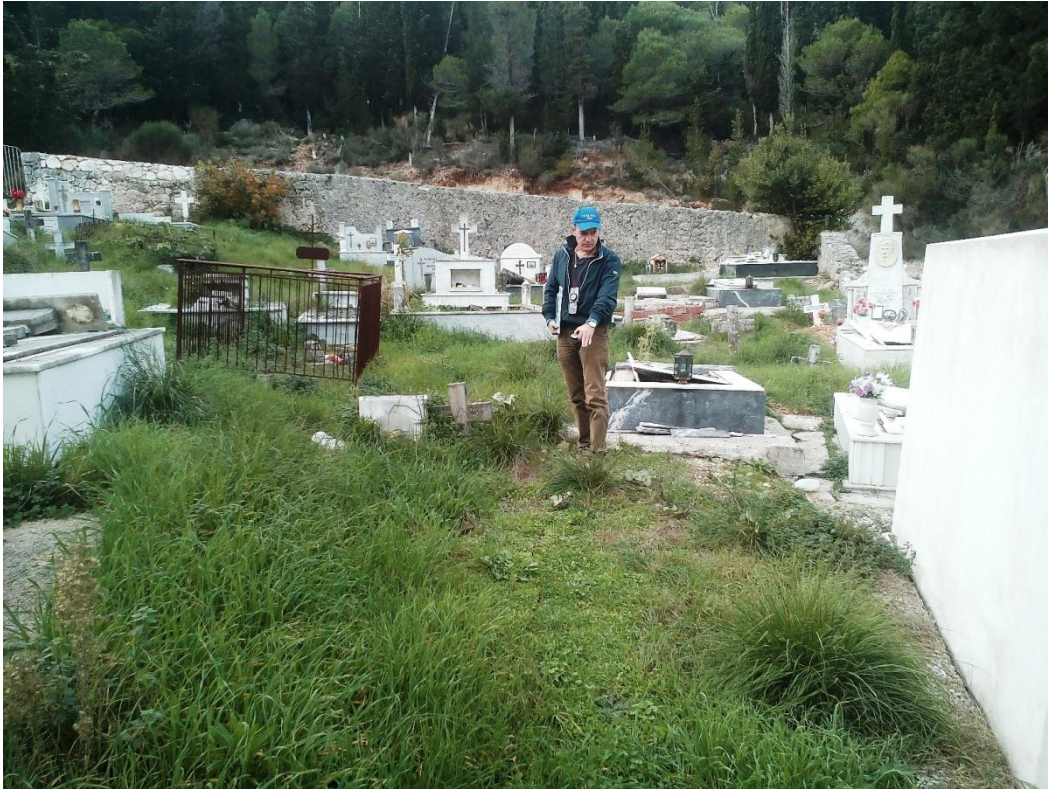
Figure A8 Field photo of damaged cemetery at Ypapanti church, to the west of Dragano village. View to the north. Date photo was taken 21 Nov. 2015.

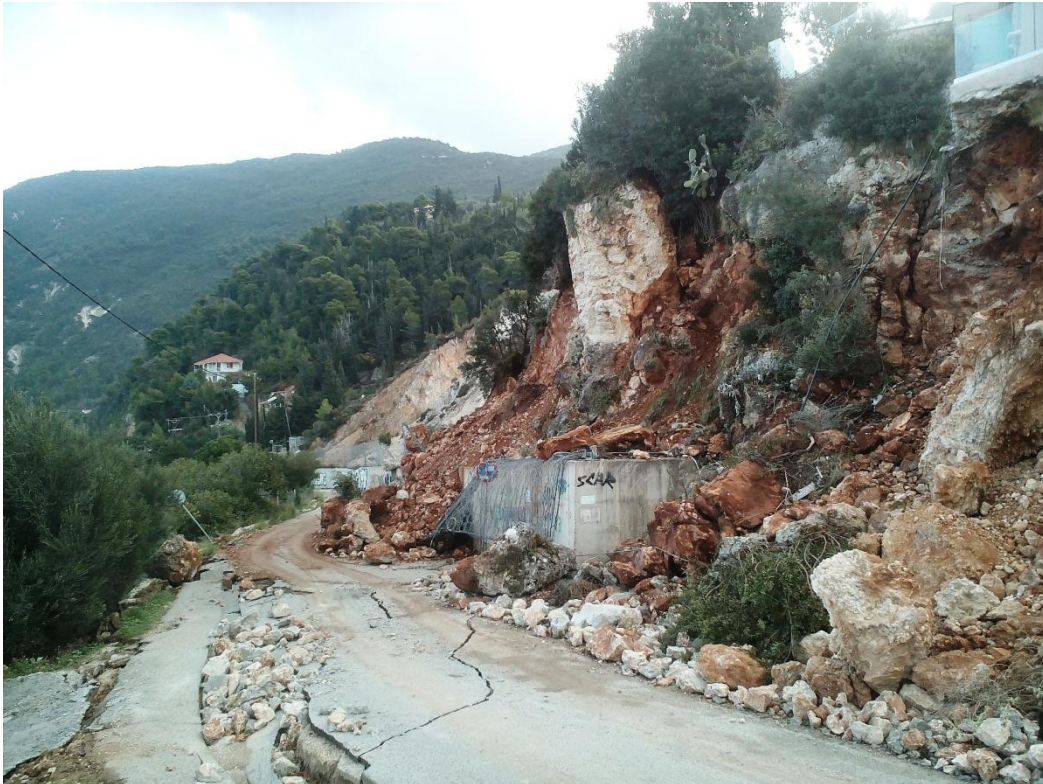
Figure A9 Field photo of landslide at Agios Nikitas village. View to the north. Date photo was taken 22 Nov. 2015.

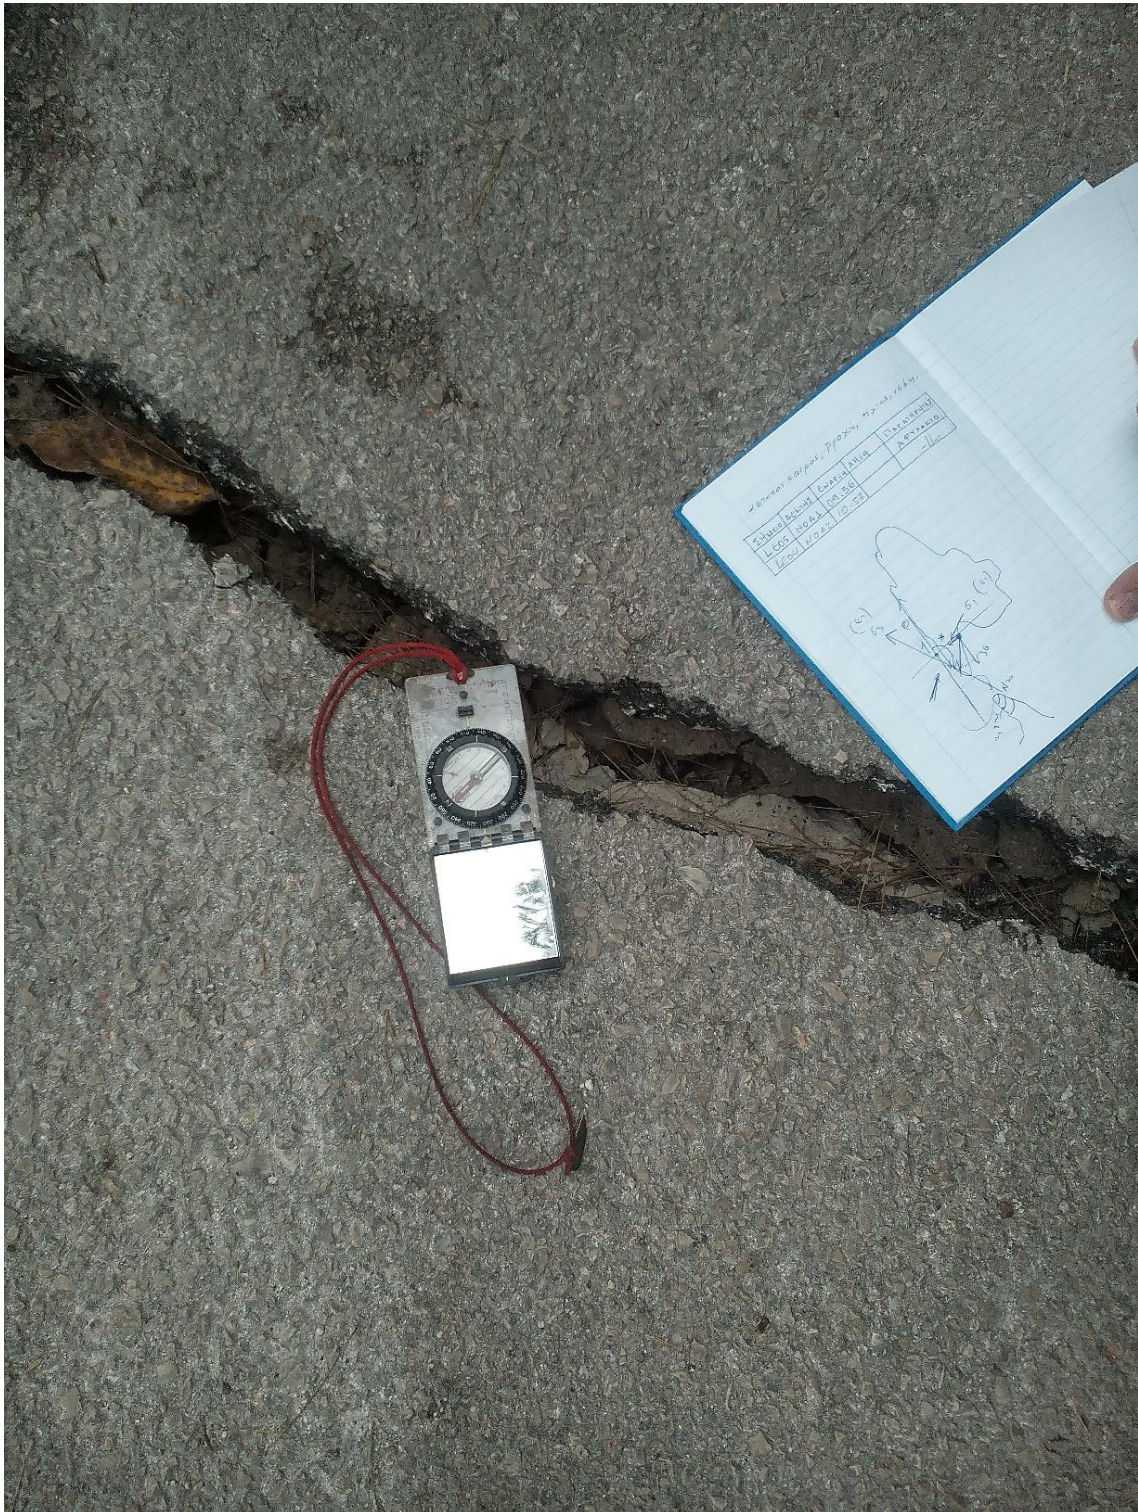
Figure A10 Field photo of 7cm wide tensional crack at Dragano village. Extension azimuth is N130°E. Nadir view. Date photo was taken 22 Nov. 2015.
