REPUBLIC OF TURKEY
MINISTRY OF INTERIOR
**DISASTER AND EMERGENCY
MANAGEMENT AUTHORITY**

**THE $M_w=6.6$ SAMOS ISLAND
(OFFSHORE- İZMİR) EARTHQUAKE
OF 30 OCTOBER 2020**

**EARTHQUAKE DEPARTMENT
ANKARA
DECEMBER 2020**

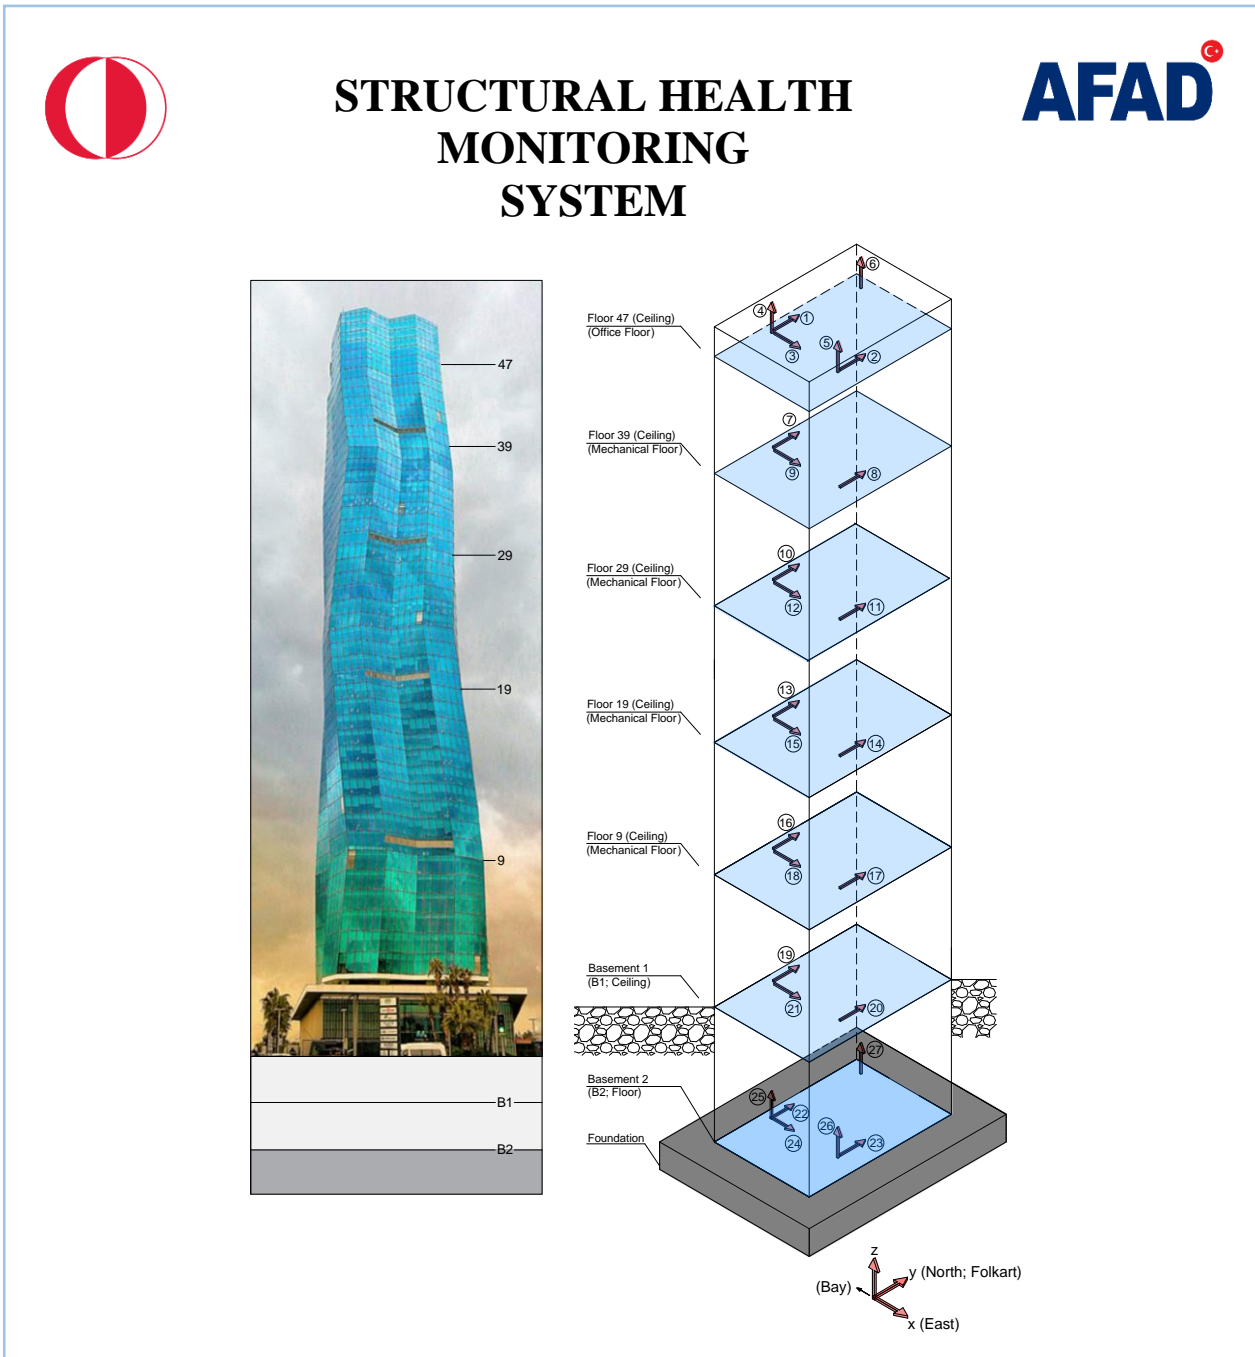
Figure 5.6. The building in İzmir and the floors that the structural health monitoring system was installed

initiated and supported by AFAD within the scope of National Earthquake Research Programme. Within the framework of the study performed together with the academicians of METU Civil Engineering Department, a structural health monitoring system was installed on a building in İzmir city center, which is 216 m tall and 48-story (Figure 5.6).

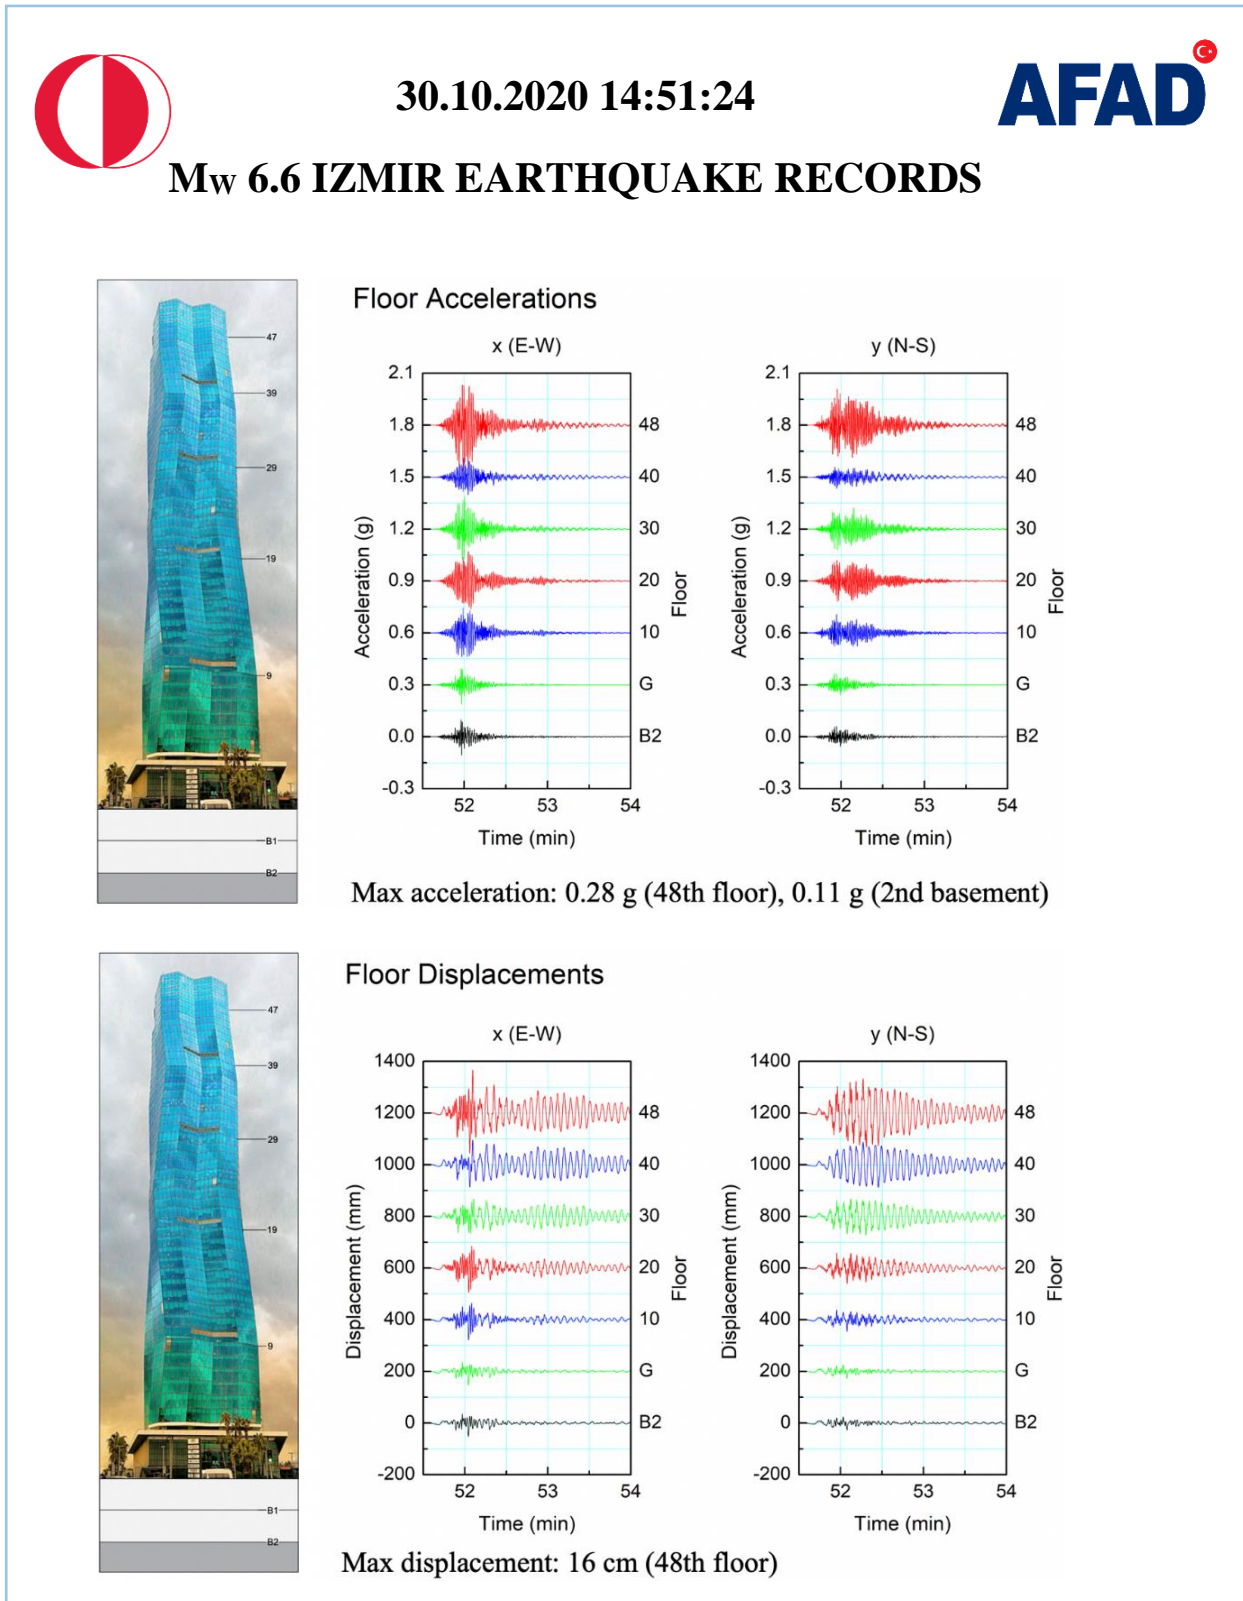
Figure 5.7. Acceleration and displacement values obtained at different floors of the building that structural health monitoring system was installed

During the earthquake, the system recorded acceleration value of 280 gal and 110 gal at the 48th floor and 2nd basement, respectively while the displacement at the 48th floor is 16 cm (Figure 5.7).
