Newsletter of **Environmental, Disaster, and Crises Management Strategies**

Issue No.15 | November 2019

The November 26, 2019 Mw 6.4 Durrës (Albania) earthquake

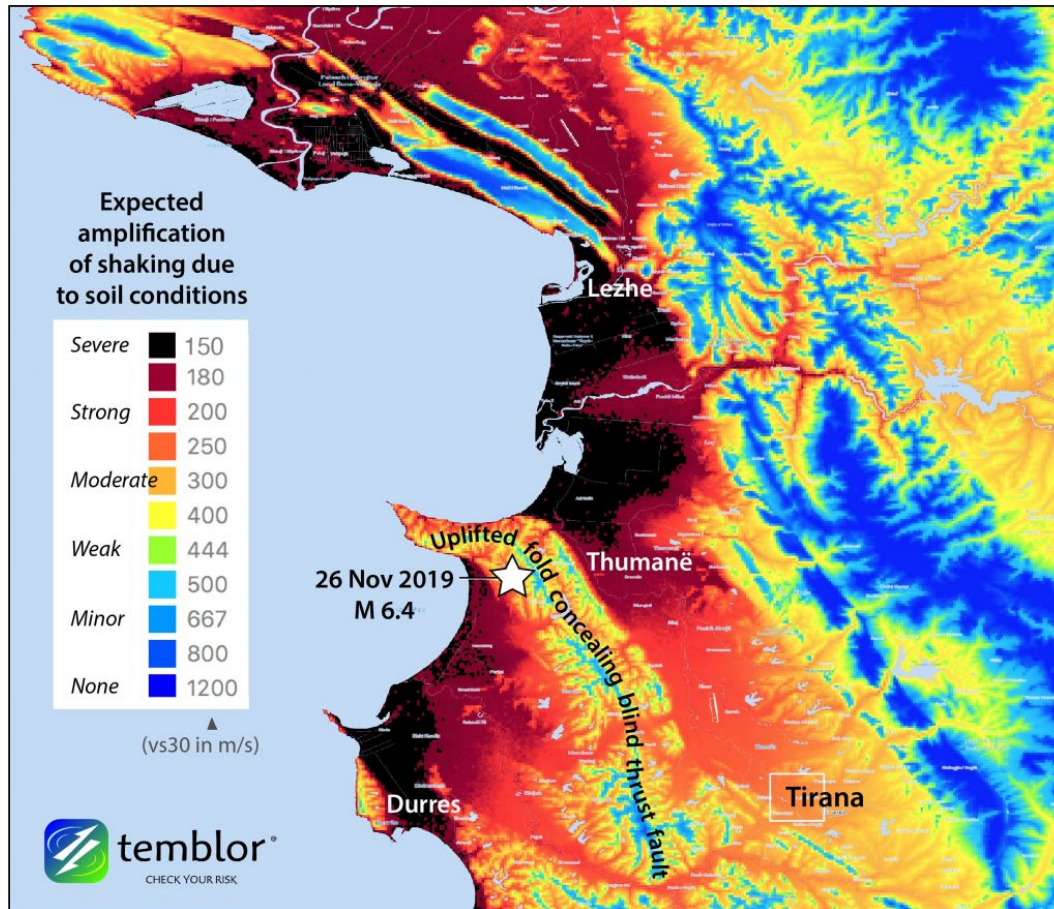
EFFECT OF THE GEOLOGY ON THE AMPLIFICATION OF SHAKING PRODUCED BY THE NOVEMBER 26, 2019 EARTHQUAKE

The shaking produced by the Mag. 6.4 shock was almost certainly amplified in the weak, unconsolidated basins and coastal estuaries surrounding the epicenter (from *Stein and Sevilgen, 2019*; <https://temblor.net/earthquake-insights/albania-earthquake-strikes-highest-hazard-zone-in-the-balkans-devastating-nearby-towns-10153/>)

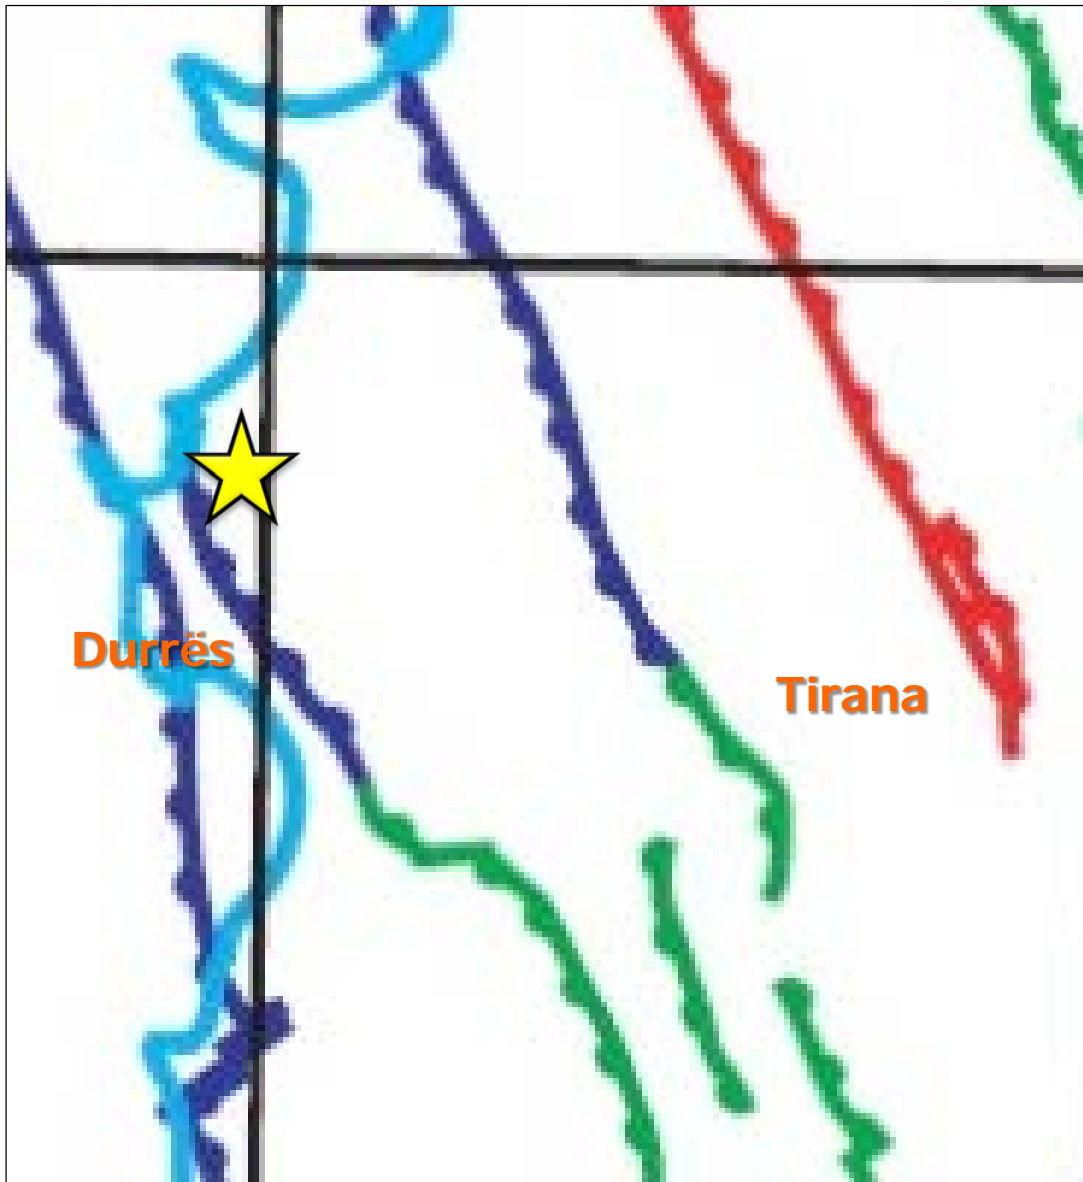
ACTIVE FAULT ZONES AND FAULTS OF THE NOVEMBER 26, 2019 EARTHQUAKE-AFFECTED AREA

The 2019 earthquake affected area is dominated by NW-SE striking reverse active faults.

Blue lines correspond to faults activated during Middle Pleistocene - Holocene (or Quaternary), the green lines to faults activated during Pliocene - Lower Pleistocene and the red lines to faults activated during Pre-Pliocene period.

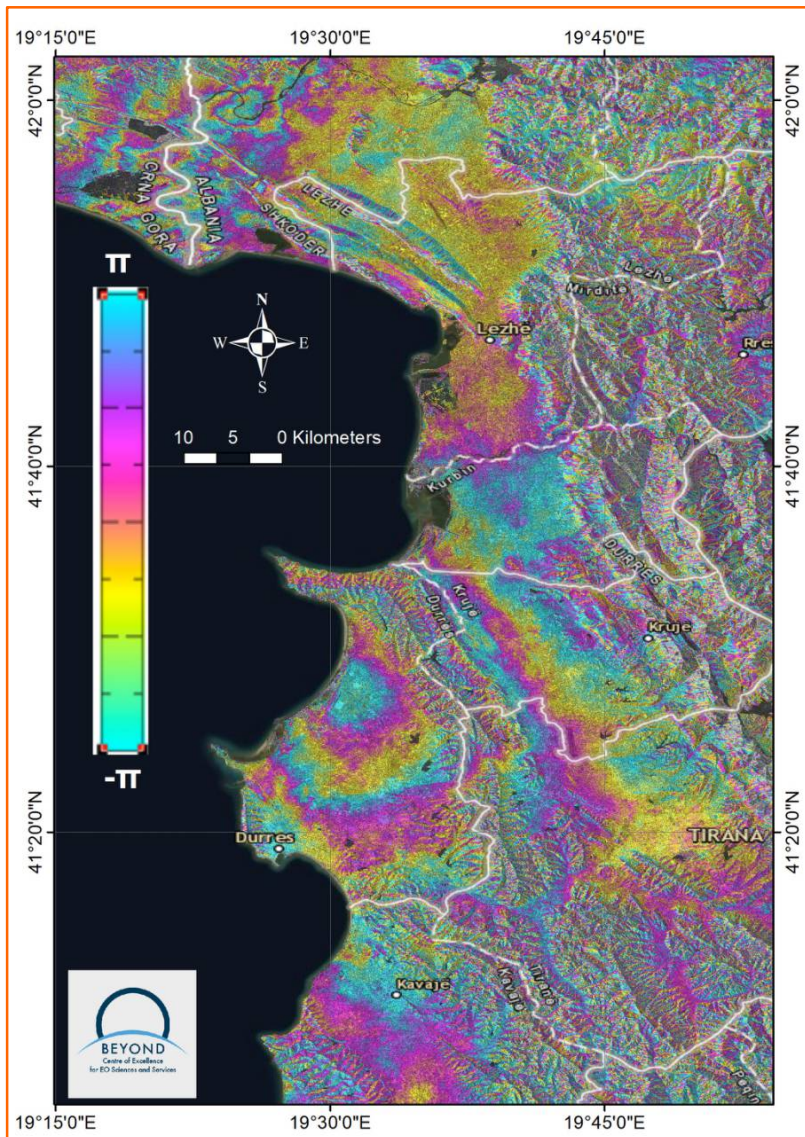
Interferogram for the November 26, 2019 Durrës earthquake. Each color fringe represents 2.8 cm of surface displacement in the satellite line-of-sight.

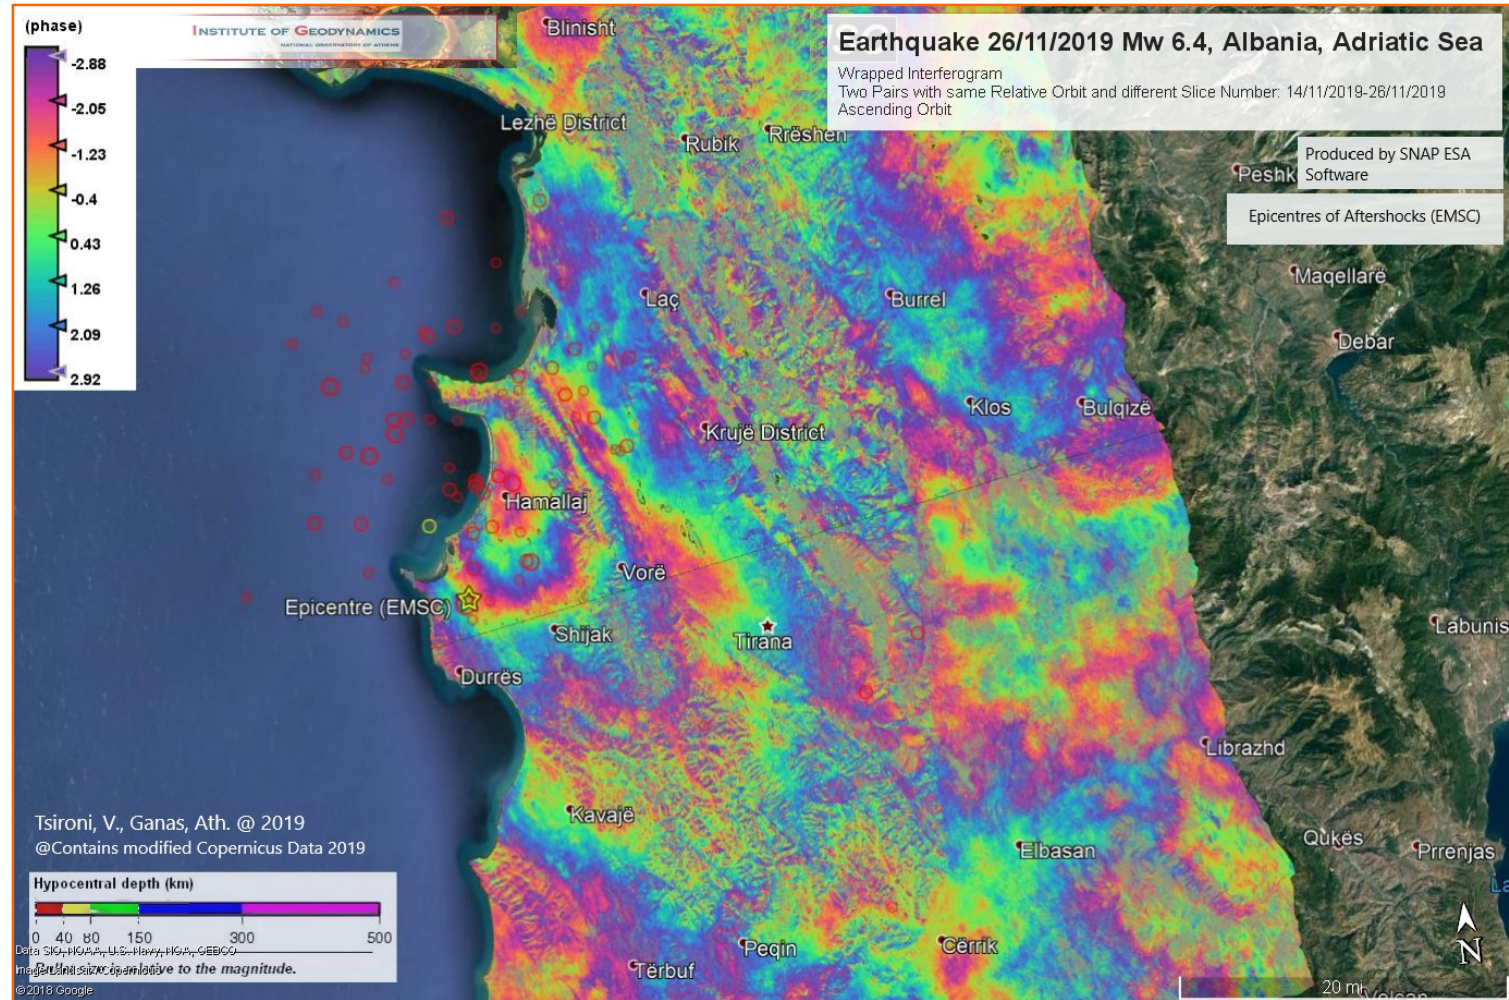
The first differential interferogram of the November 26, 2019, Mw 6.4 Durrës earthquake using data from the Sentinel-1 satellite (ascending orbit). There are 3 fringes with a NNW-SSE direction as well as the seismic fault. Uplift of tectonic origin is observed up to 8.4 cm at Hamallaj (15 km NE of Durrës) (*Tsironi and Ganas, 2019*)

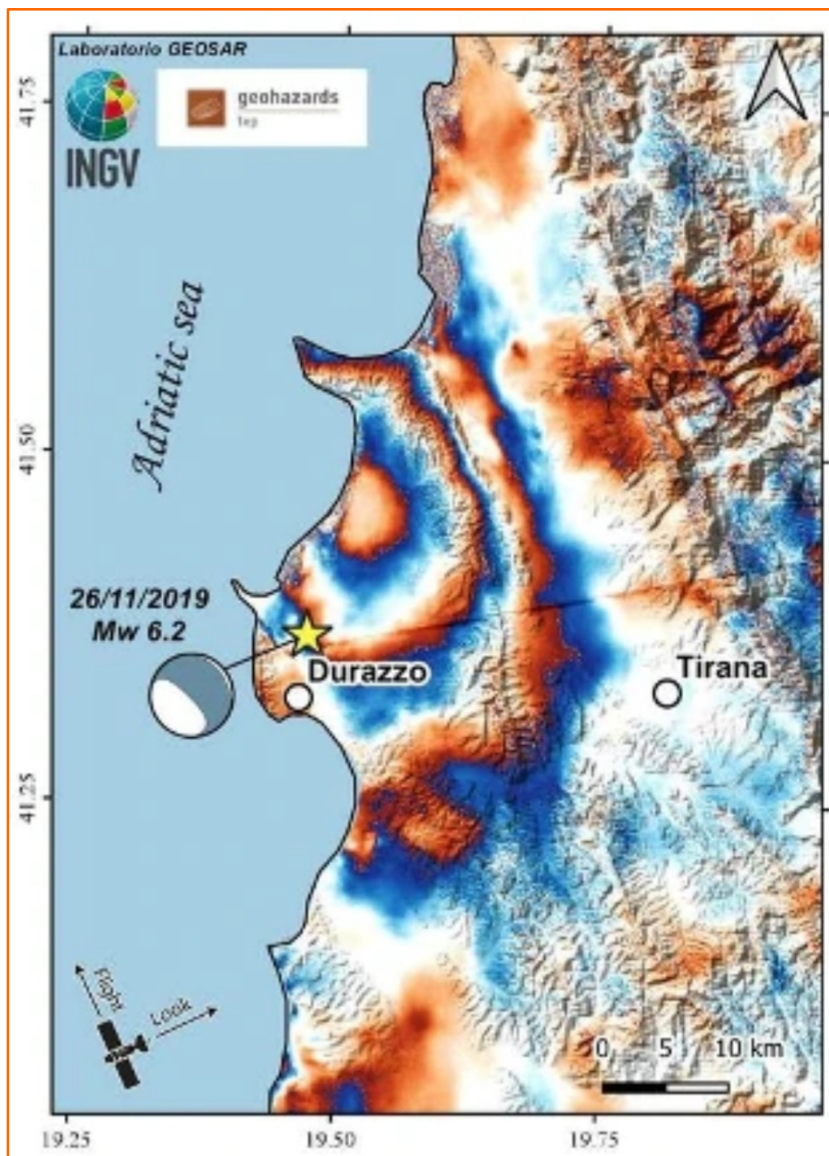
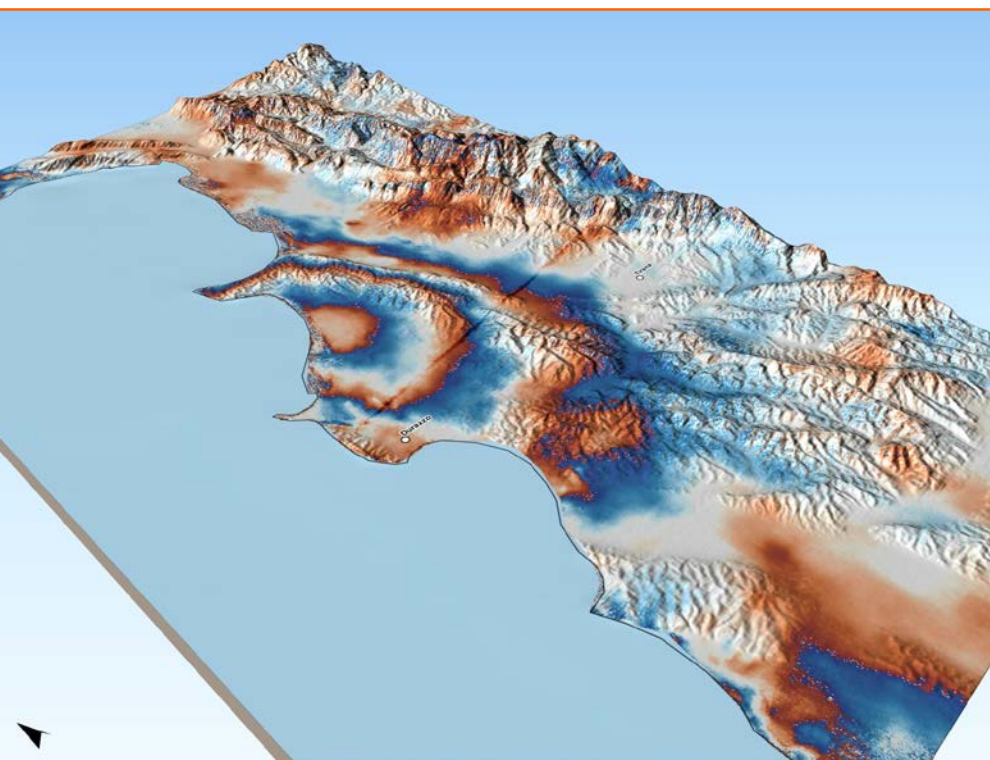
The earthquake raised the ground by about 10 cm near the city of Durrës. This is concluded by the radar images taken by the Sentinel-1 satellites of the European Copernicus program of the European Space Agency (ESA) and the European Commission, analyzed by the seismologists of the National Institute of Geophysics and Volcanology (INGV).

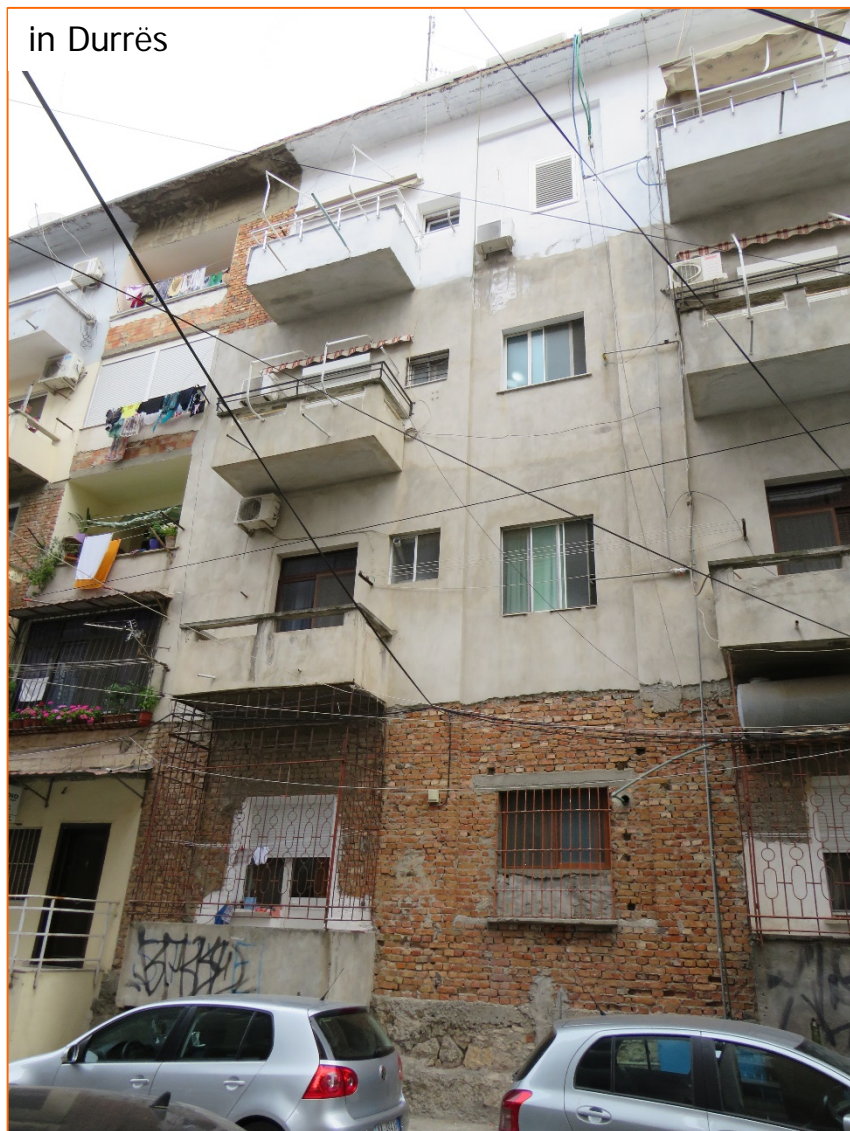
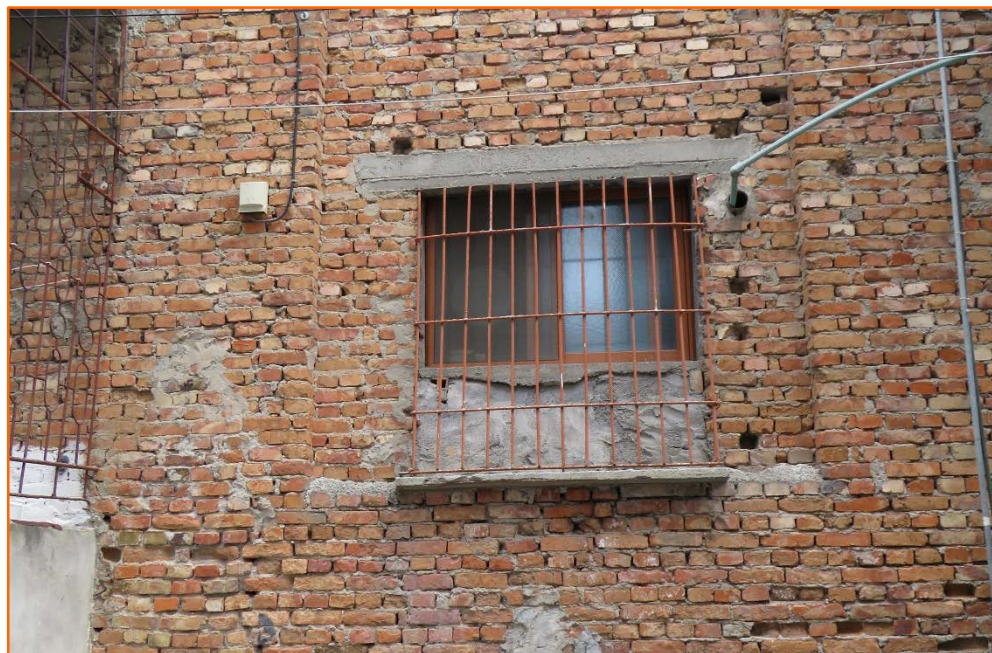
in Durrës

Unreinforced masonry (URM) construction should not be used today. They do not present good performance during earthquakes. It is significant to mention that the majority of fatalities induced by earthquakes around the world have attributed to collapse of unreinforced masonry buildings. They are heavy brittle structures, which usually suffer heavy structural damage.

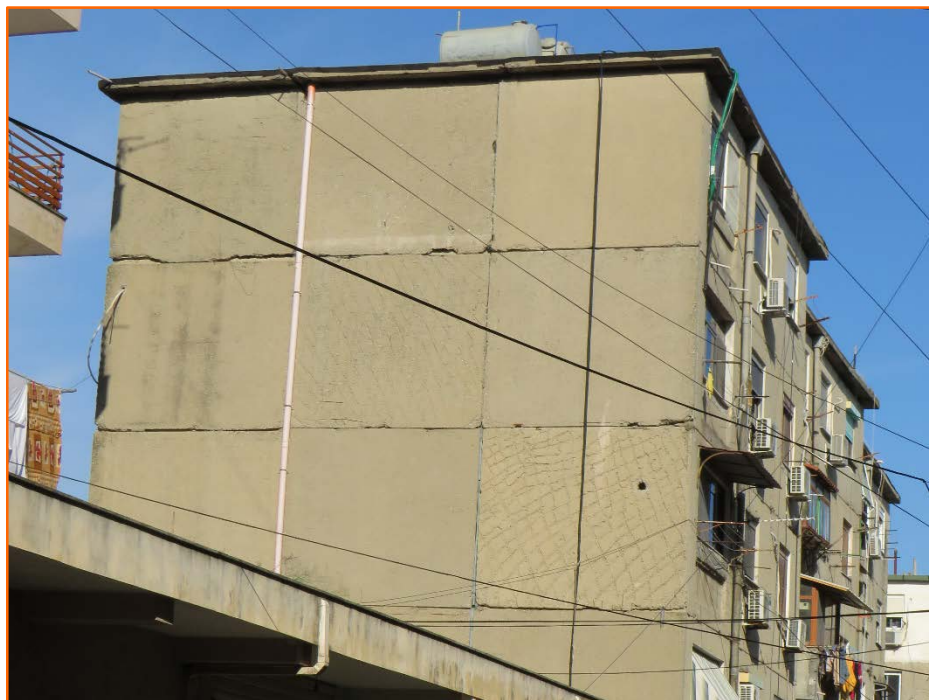
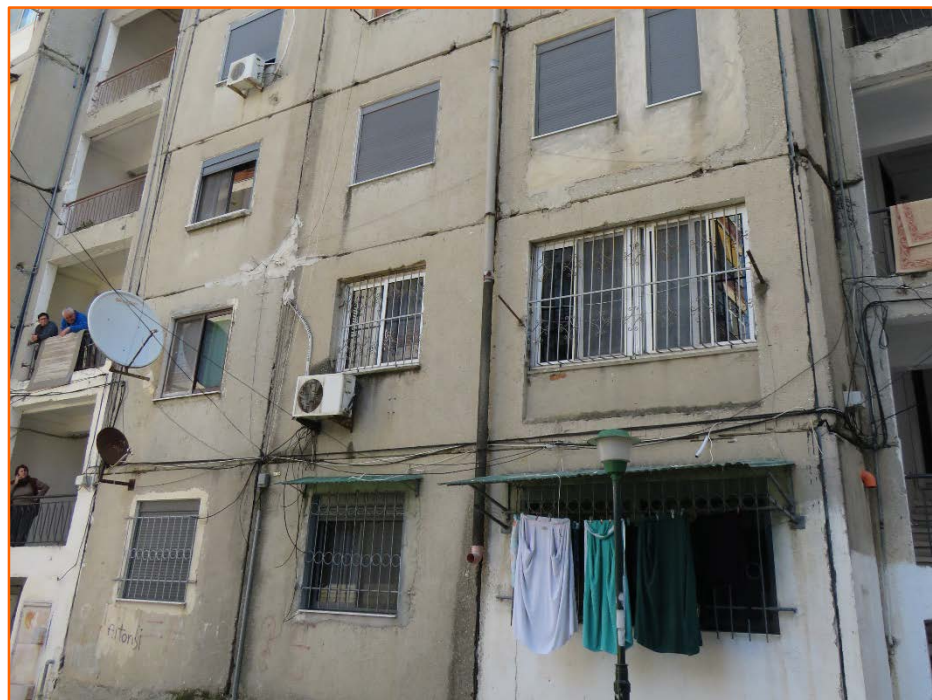
In the majority of these structures, the prefabricated concrete walls are not covered with plasters and the welding joints between the prefabricated concrete walls have not been sealed. Thus, these buildings are not protected from the aggravating environmental conditions including humidity, rainfall, temperature variations, snowfall resulting in quick and easy ageing of materials.

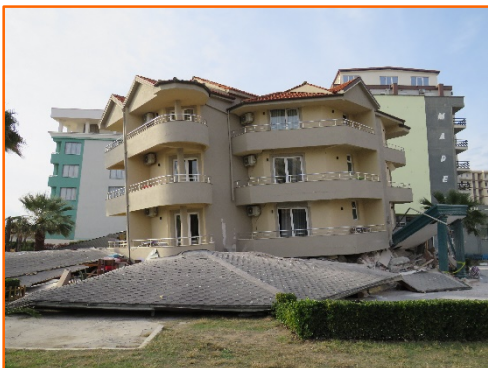
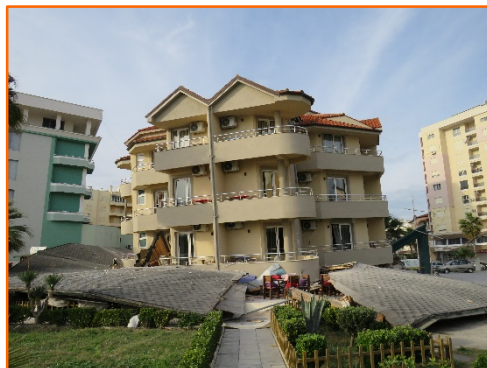
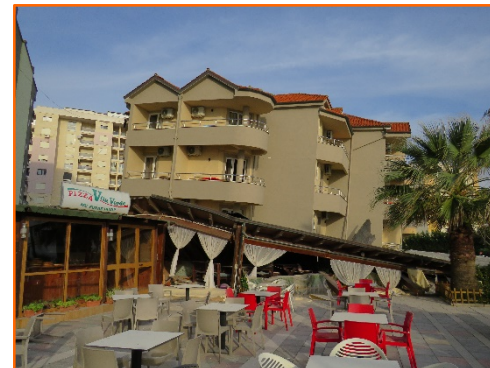
Hotel Vila Verde was founded on the coastal zone of Durrës, few meters from the sea. No damage was induced to the hotel during the September earthquake. The two lower floors totally collapsed during the November earthquake, while the structure above remained almost intact.

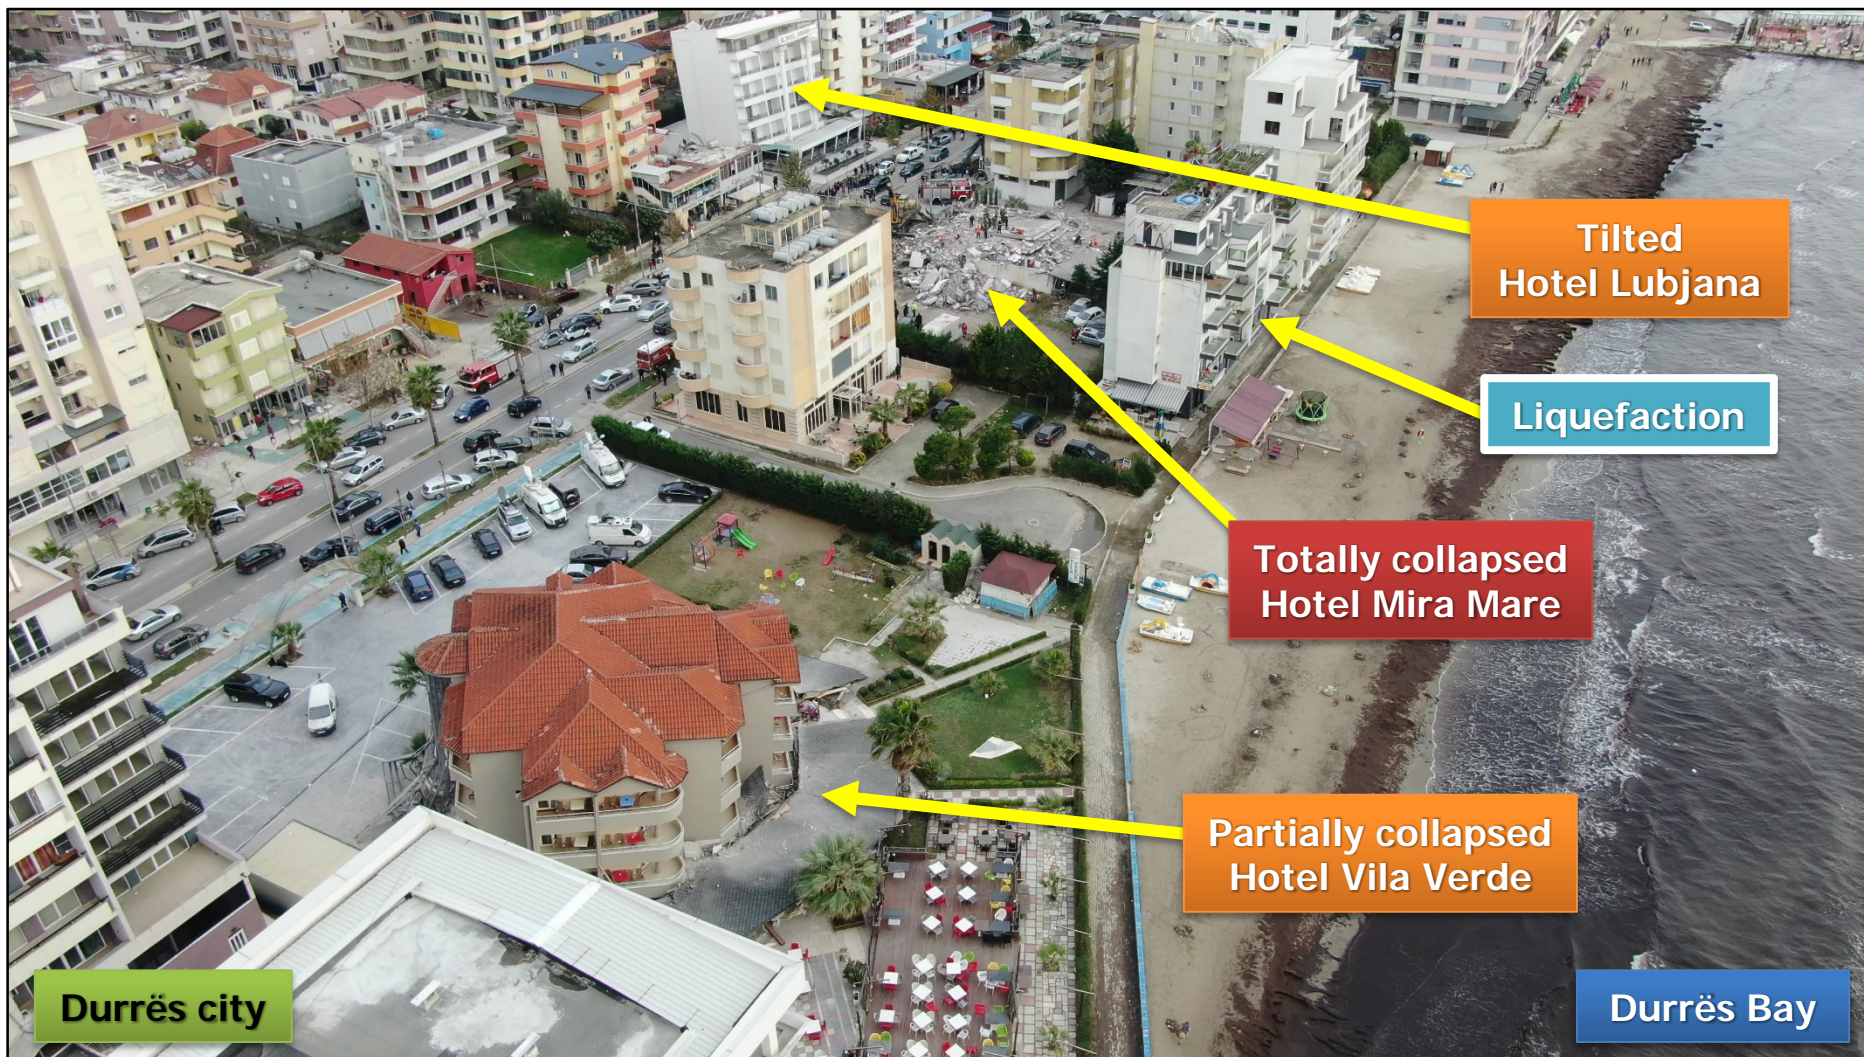
LIQUEFACTION PHENOMENA AND VERY HEAVY STRUCTURAL DAMAGE

The area, where three hotels suffered very heavy structural damage, is one of the most affected areas by the November 26, 2019 Mw 6.4 earthquake. Mira Mare Hotel totally collapsed, Vila Verde Hotel partially collapsed and Lubjana Hotel tilted after column collapse and probably liquefaction.

Close to the Mira Mare Hotel liquefaction phenomena were generated comprising ejection of sand through cracks, formation of small sand volcanoes and silt-covered pavements. The site with the three heavily damaged buildings is close to the sea and is composed of unconsolidated recent deposits that constitute the soft ground of the area.

The soft ground usually suffers differential displacements including subsidence among others. The multistorey buildings are trying to adapt to these displacements and restabilize. This adaptation and restabilization of the building is putting more strain on its structural and non-structural elements resulting in either slight deformation or failure of these elements. When a strong earthquake occurs in a distance from the soft ground and the multistorey buildings, then the synergy of the earthquake loading along with the local soil conditions, the shallow water table, the construction defects and the pre-existing stress of the building may result destruction. Moreover, damage from differential soil settlements are homologous to damage induced by an earthquake.

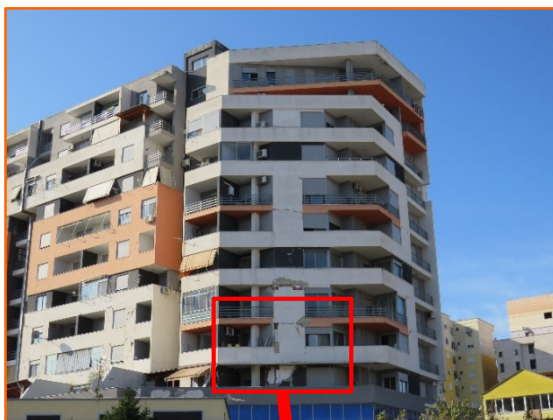
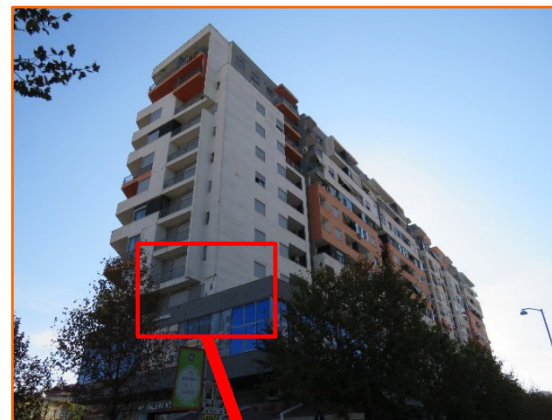
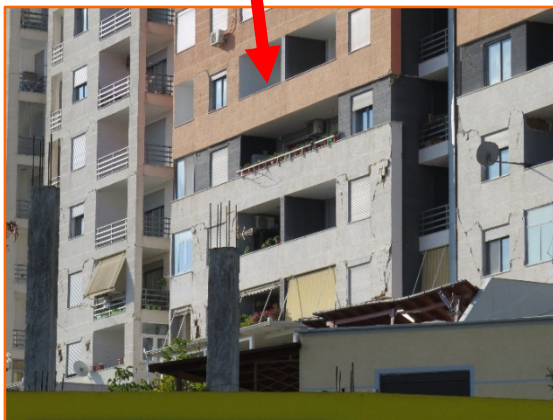
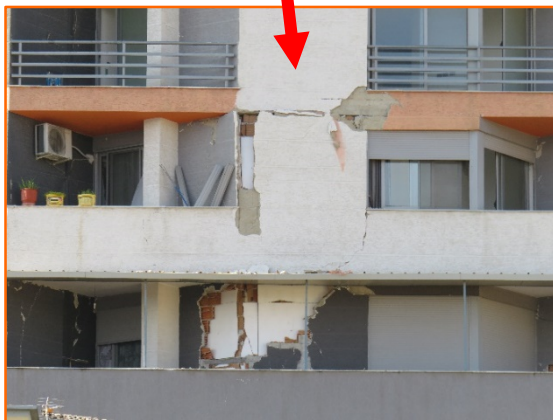
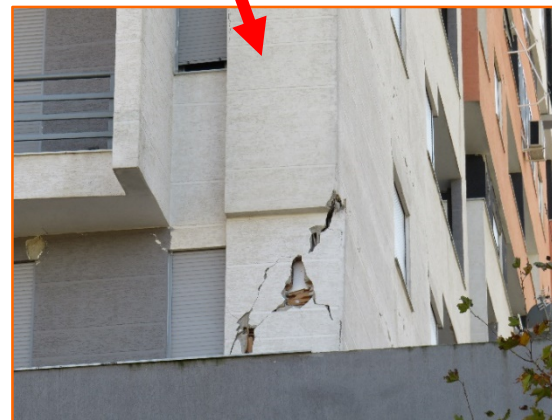
A multistorey building in Durrës with damage observed only in the three lower storeys, while the upper storeys remained intact by the earthquake. Cracking of plaster, detachment of plaster from the brick walls, cracking and partial collapse of brick walls were mainly observed. The adverse characteristics of this building comprise cylindrical and thin columns and almost triangular shape of the building in top view. Moreover, beams are totally missing, especially in the interior of the structure. This lack constitutes a rule in the affected area. The slabs are prefabricated reinforced concrete hollow core slabs with no connections between them.

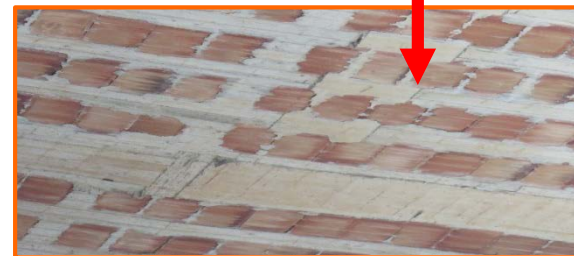
Exterior non-structural walls made of hollow clay bricks outside the reinforced concrete frame suffered damage

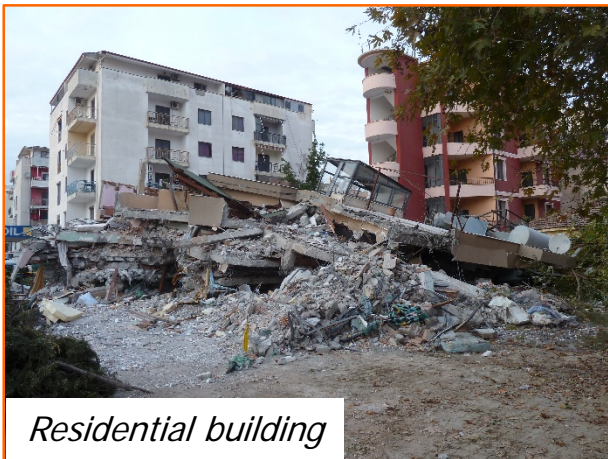
Residential building

The presented residential building (upper photos) and the hotel (lower photos) were among the totally collapsed buildings in Durrës. The destruction was almost complete with collapsed slabs leaving no gaps and empty spaces between them. The tangled mass of earthquake building debris reflects not only the strong seismic motion but also the poor construction of buildings and the inadequate quality of construction materials.
